**Former Williamsburg Works
MGP Site, Brooklyn,
New York**

**Analysis of Available Data to
Track Sources of
Contamination**

January 30, 2015

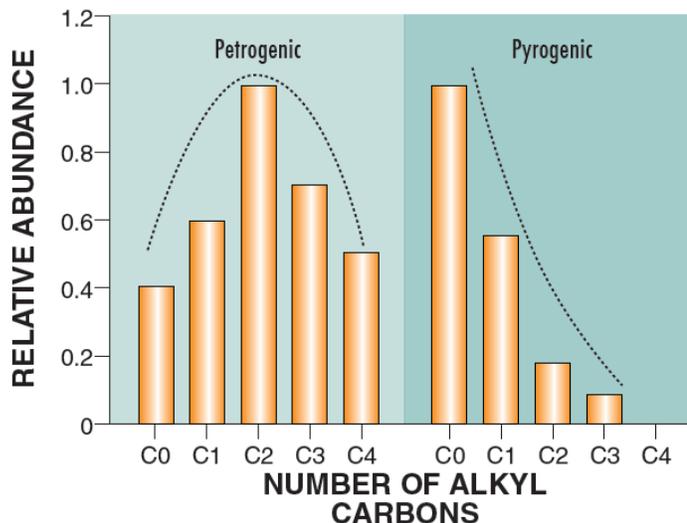
concentrations of alkylated PAHs are significantly higher than those of parent PAHs is a main diagnostic feature of petrogenic PAHs. This is illustrated in Figure 4.1.

Figure 4.1 Representative distribution of alkylated PAHs formed at different temperatures within the phenanthrene series (C0 = parent phenanthrene; C1–C4 represent alkylated phenanthrenes).

In petrogenic PAHs, the relative abundance of the alkylated PAH compounds far exceeds the abundance of the parent (unsubstituted) compounds (e.g., Boehm 2006). The fact that

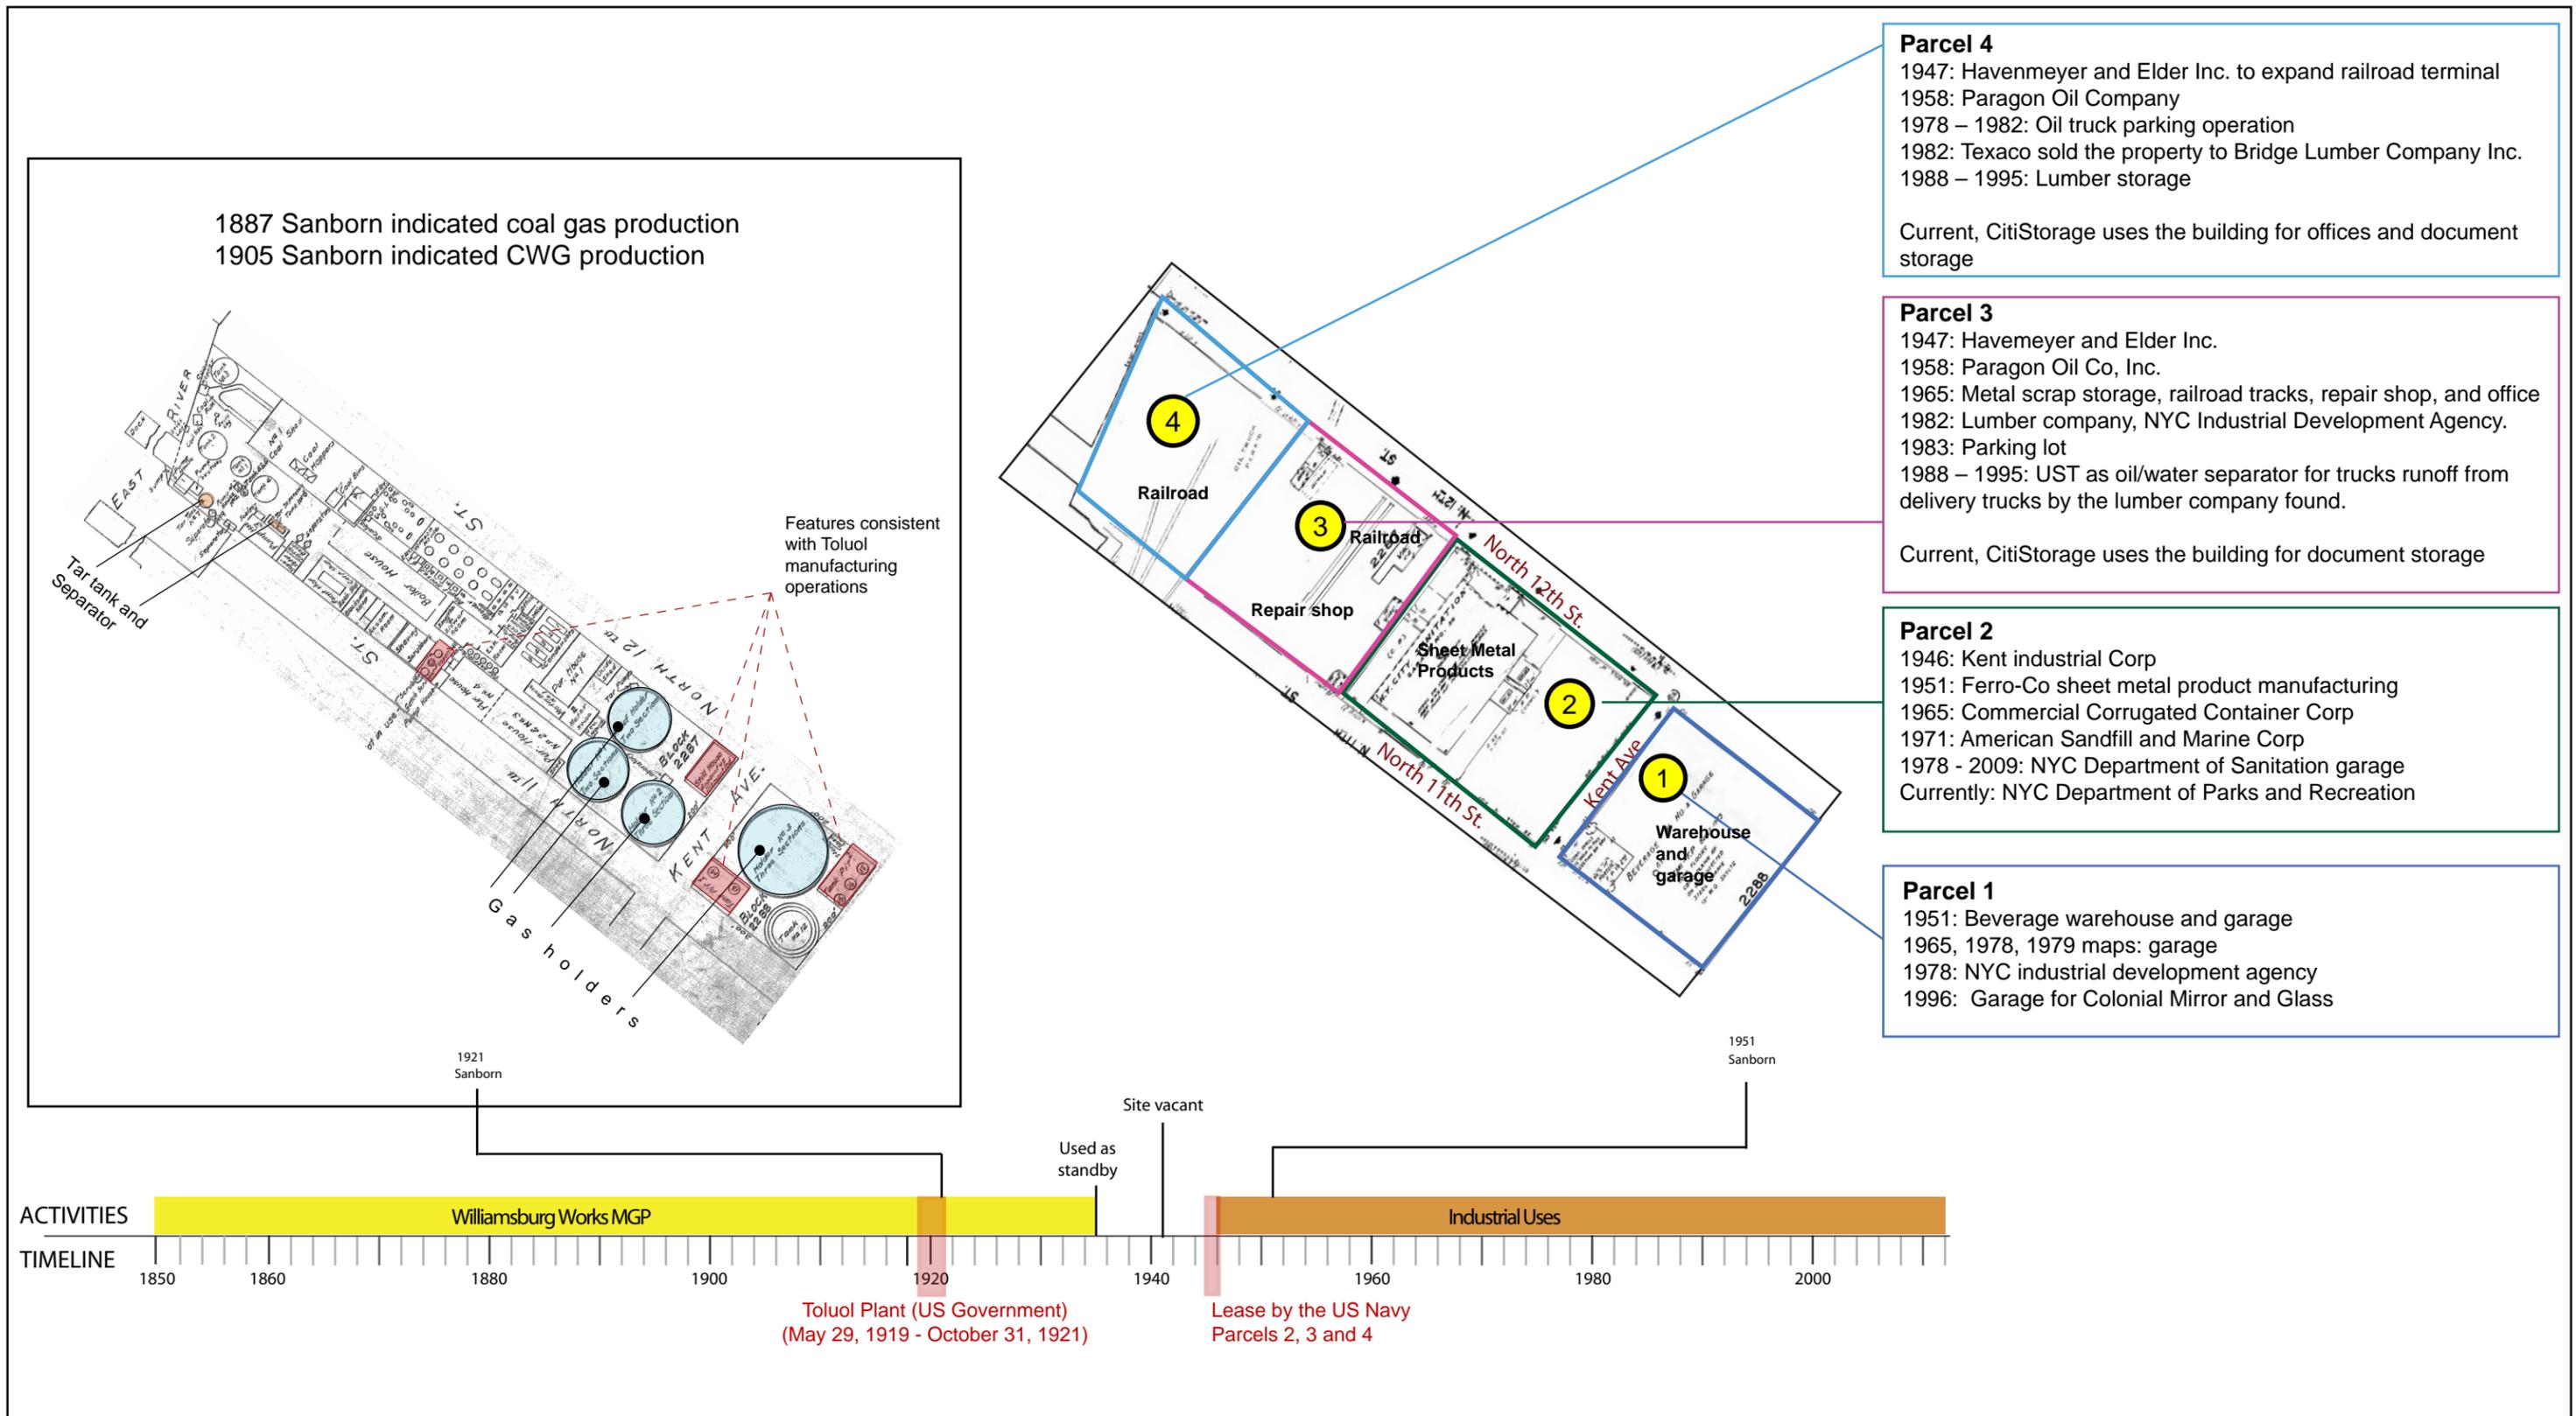
Figure 3.1 Former Williamsburg Works MGP site ownership history and operations (Parcels 1 - 4).

The ownership and historical operations for Parcels 1 to 4 are described in detail in the Remedial Investigation Report (GEI 2015), and is presented in Figure 3.1. In summary, the former gas works produced coal carbonization (CC) and carbureted water gas (CWG). In addition, petroleum products such as gas oil (and probably naphtha) were used as feedstocks in the CWG process. After 1941 (after the MGP operations had ceased), several operations occupied the site, including garages with gasoline tanks, underground storage tanks with oil/water separators, sheet-metal product manufacturing, railroads, parking lots, repair shops, and scrap metal storage, among others (see Figure 3.1). At present, Parcels 3 and 4 are occupied by buildings and therefore were not part of the environmental investigations.

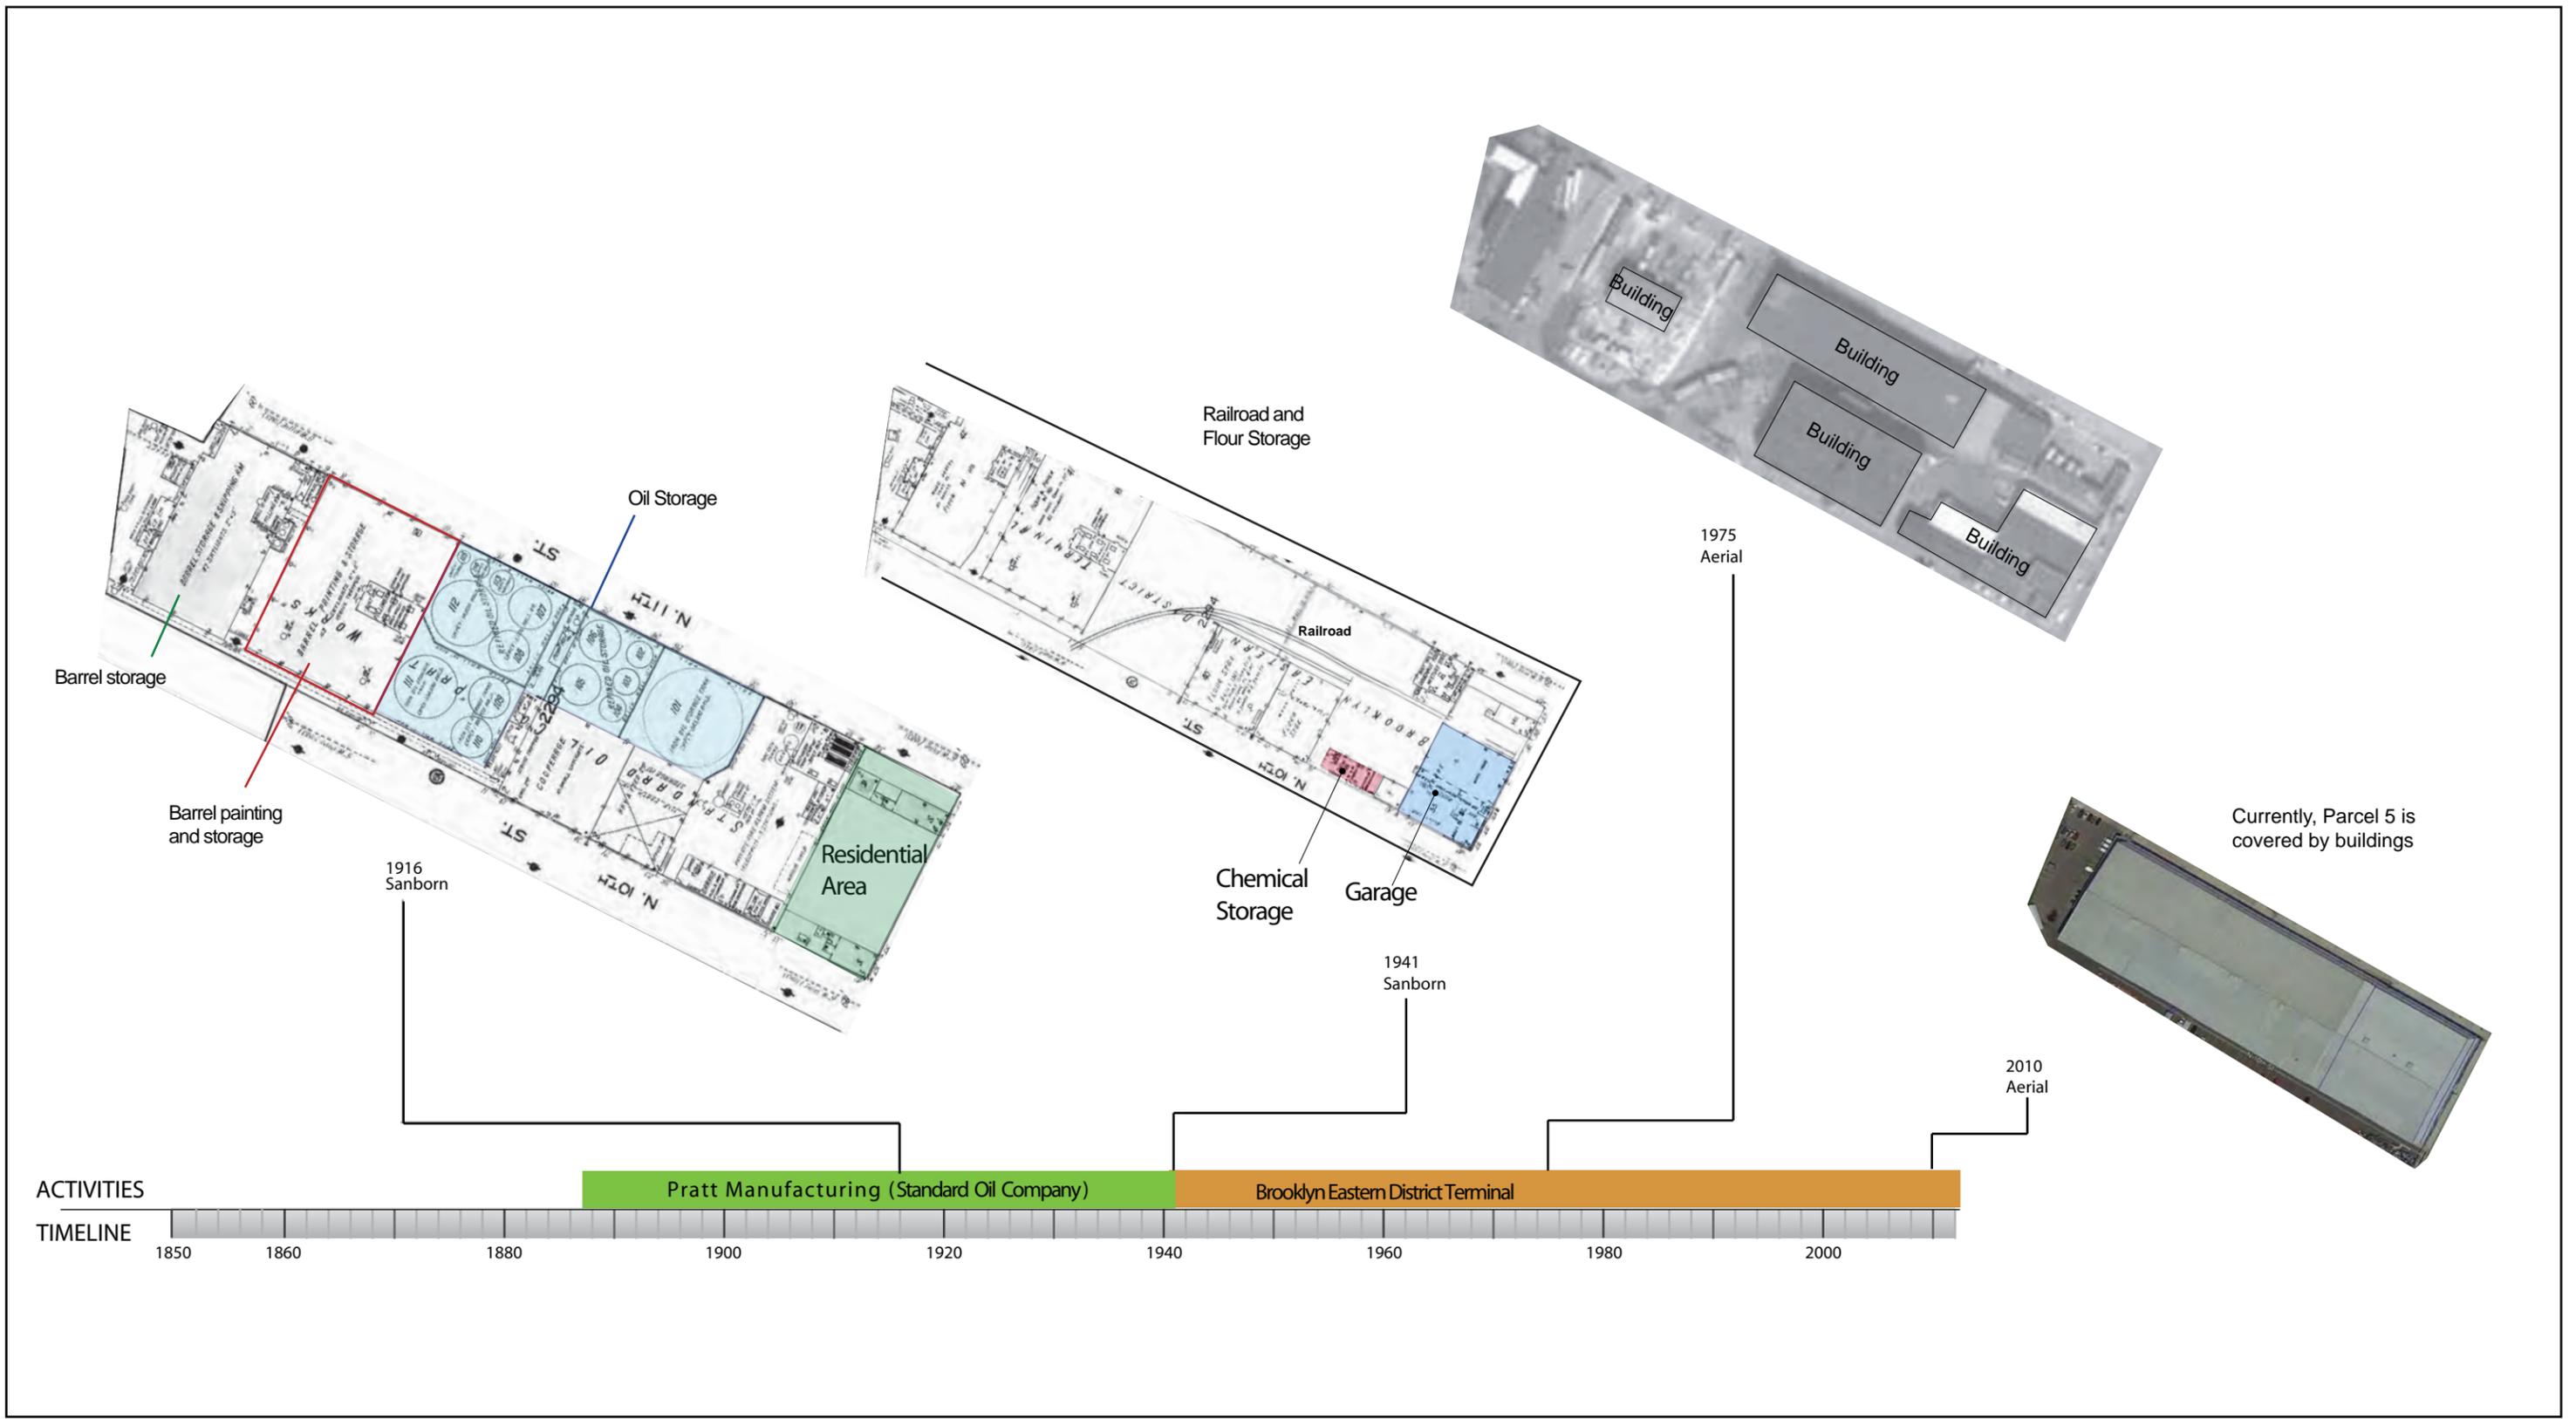
Figure 3.2.2 Parcel 5 ownership history and operations.

Figure 3.2.2 presents a summary of the historical operations on Parcel 5. This parcel was operated by Pratt Works and Standard Oil Company (1905 and 1916 Sanborn maps), and was occupied by refined oil storage tanks, barrel storage and shipping, and barrel printing and

storage. In 1941, the property was occupied by Brooklyn Eastern District Terminal and contained railroad spurs, flour storage, chemical storage, and a garage. By 1982, additional railroads and buildings were added to the site. Currently, Parcel 5 is completely covered by buildings, which confined environmental investigations to the streets surrounding the parcel.

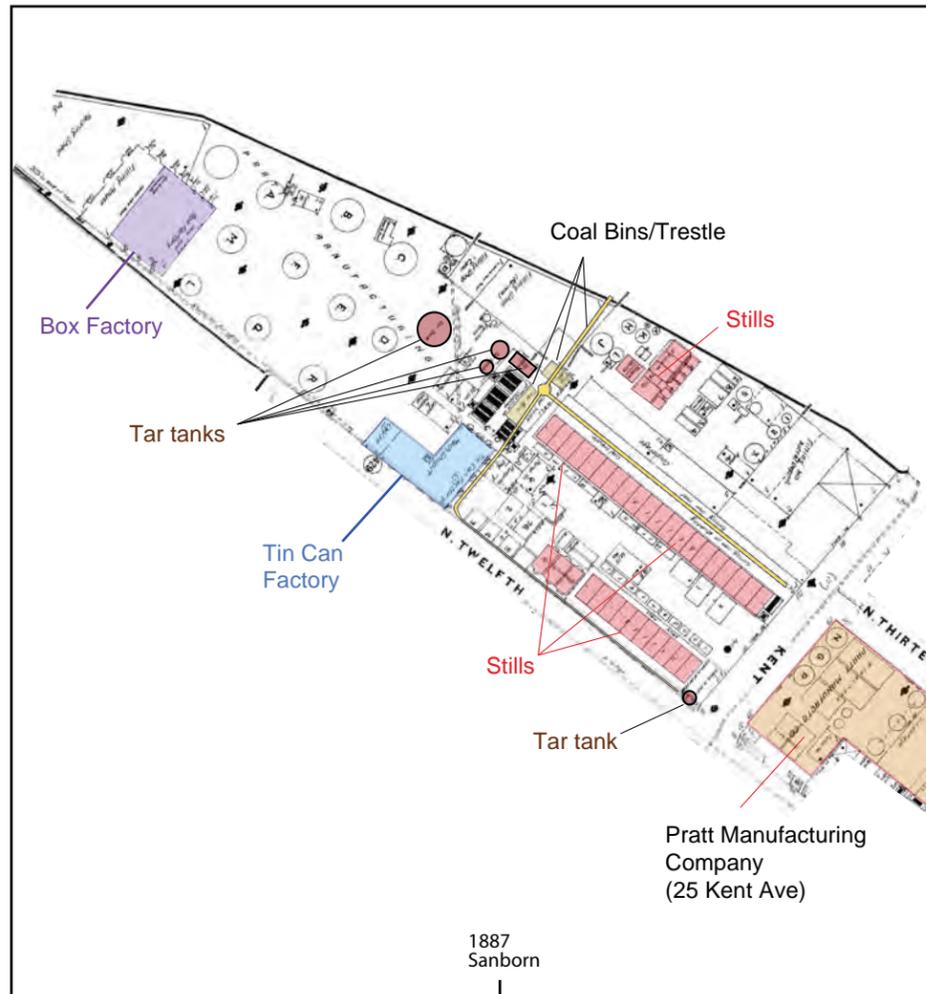
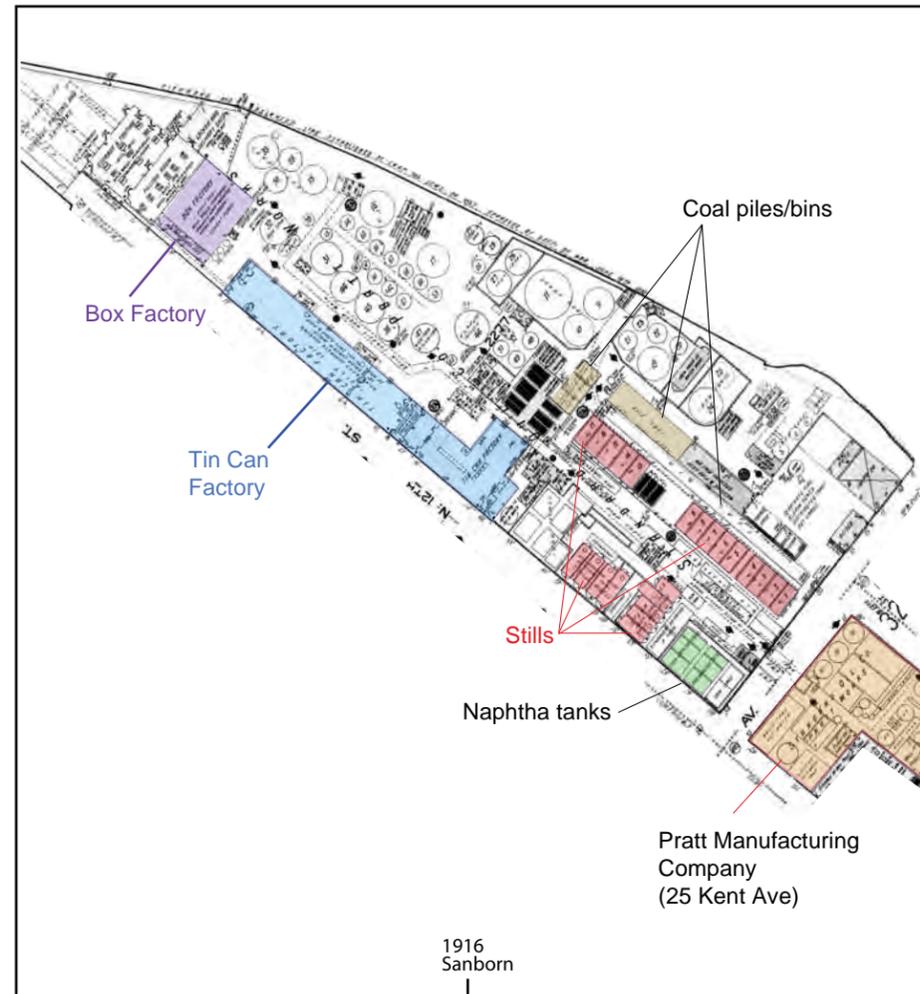
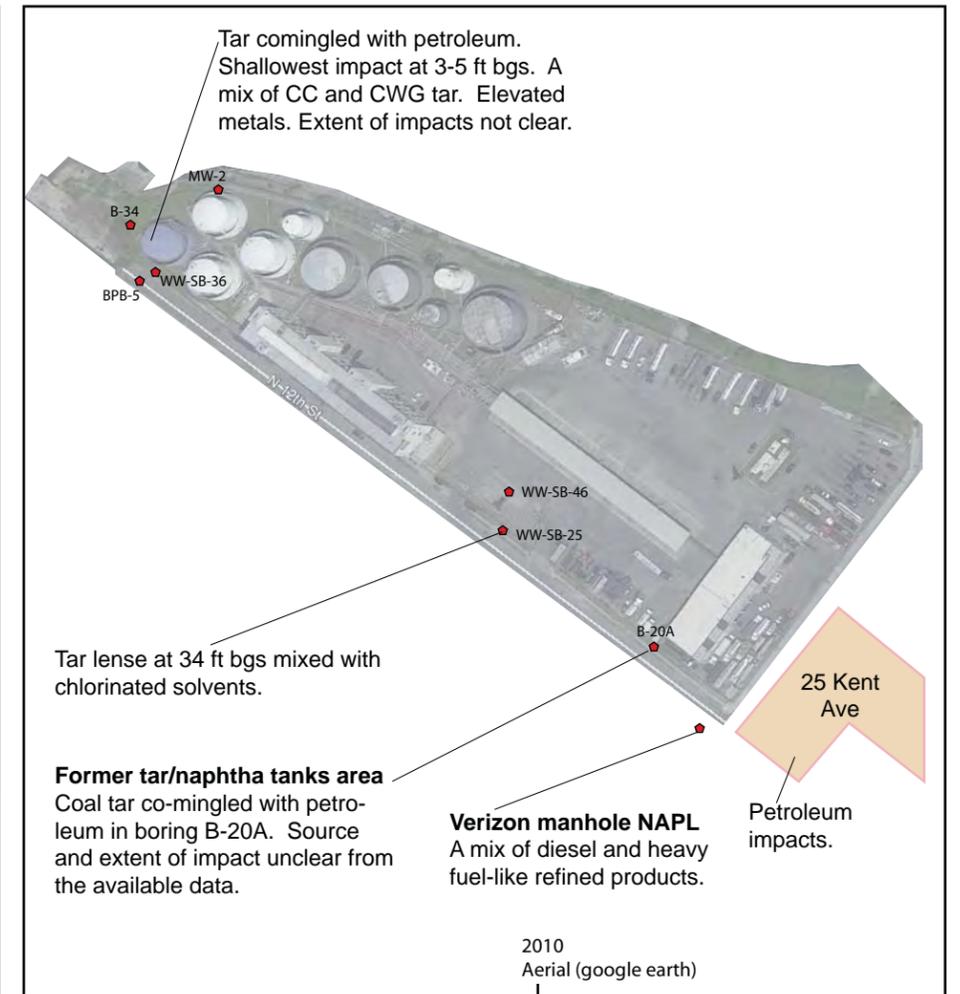
Example impacts at the Pratt Works Site along N.12th Street with spatial extent needing additional investigations

Figure 3.3 Parcel 6 ownership history and operations.

The 1887 Sanborn map shows that tar tanks and coal bins/trestles were present on Parcel 6 (see Figure 3.3). The purpose of storing tar on the Pratt Oil Works is unclear. During that period, coal was distilled to make "kerosene oil" (Gesner 1865). Gesner (1865) stated, "The introduction into common use in America of oils distilled from coal, bitumen, and incidentally petroleum was accomplished by the North American Gas Light Company of New York, in the early part of 1854. This Company... first sold the oil produced by the patentee at the Company's works on Newtown Creek... under the name of Kerosene." This coal distillation process was very similar to the MGP coal carbonization process, and the tar produced from both processes would be chemically similar.¹

Besides spills and leaks that likely occurred as part of the Pratt Works operations, several accidents were described in newspaper articles in the 1800s and early 1900s (see Figure 3.3).

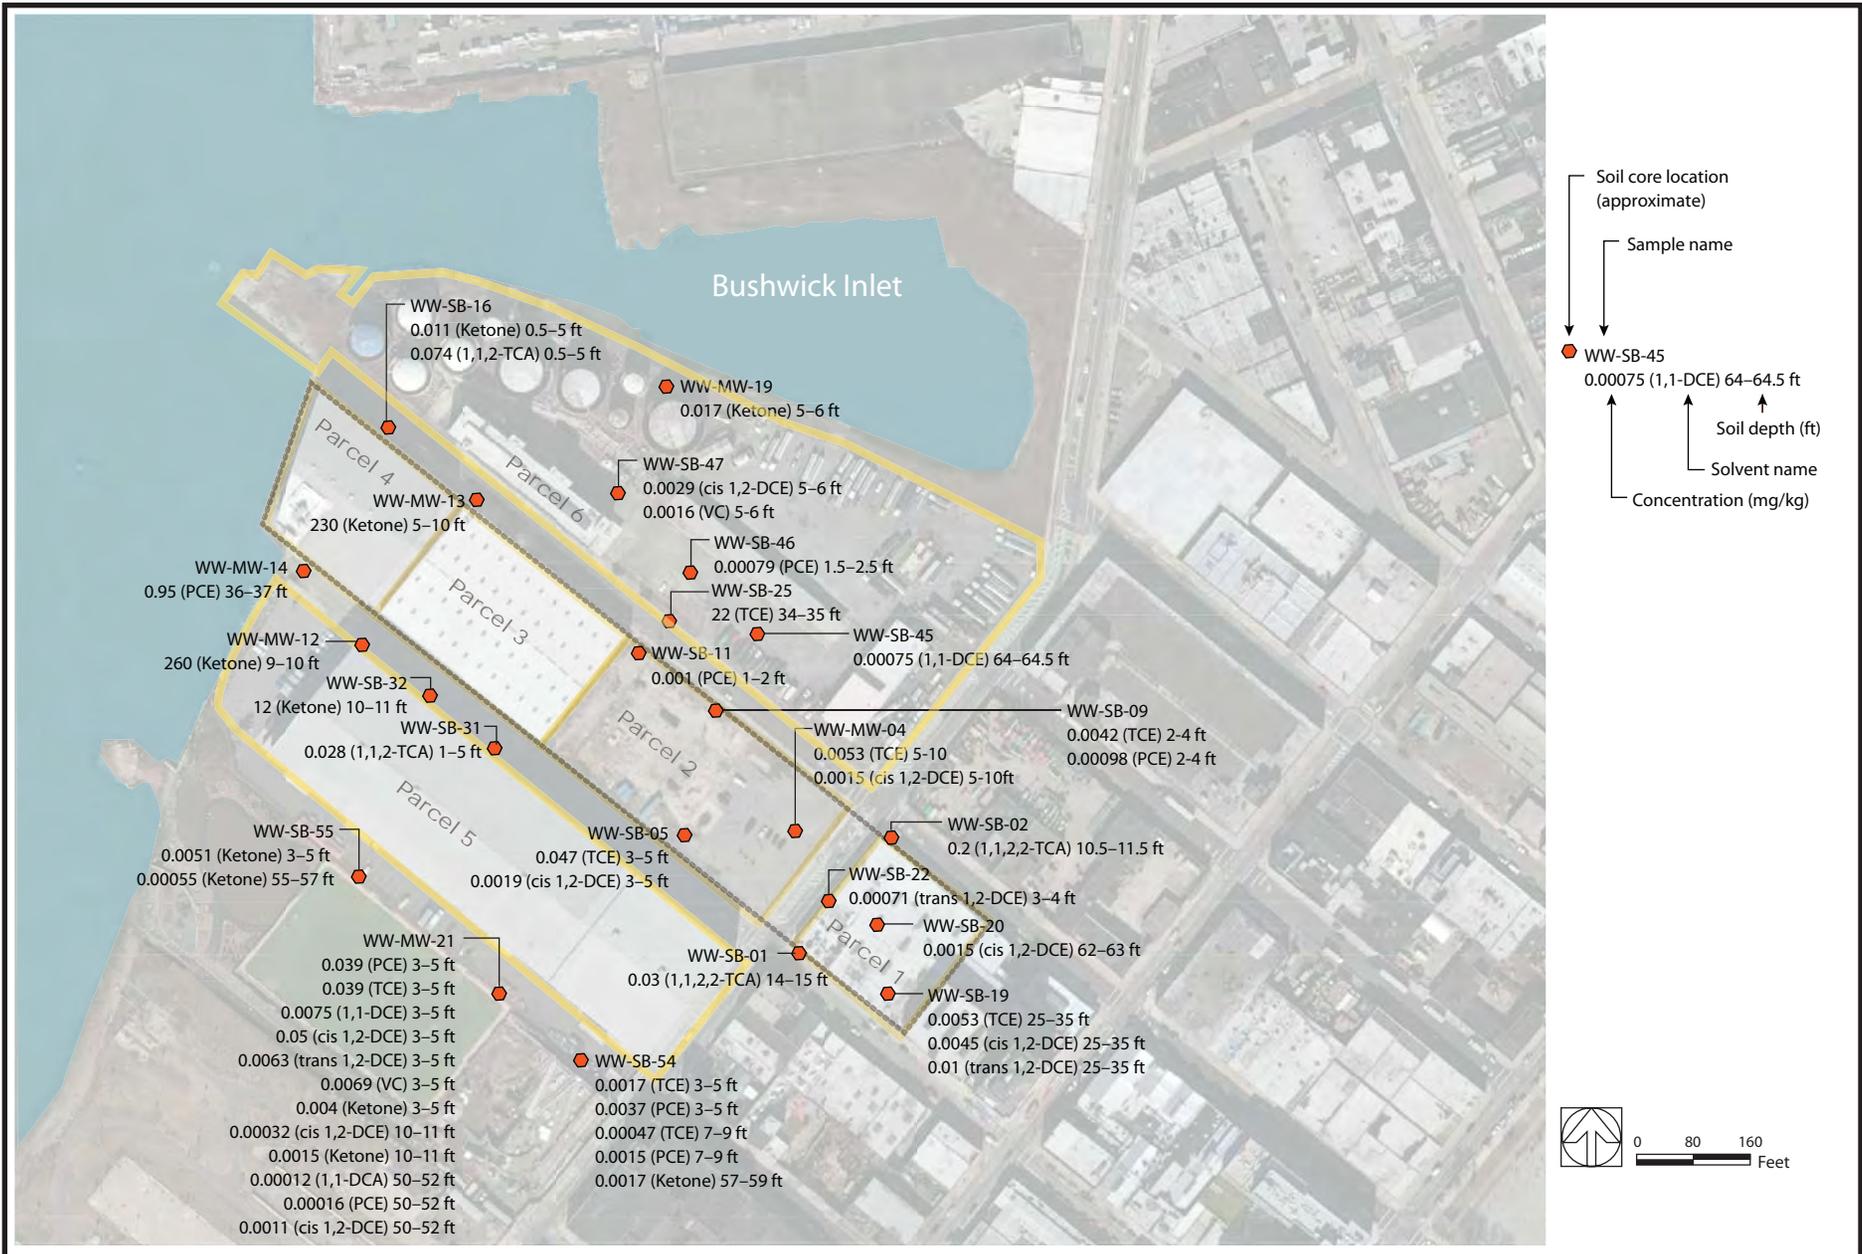
Figure 5.1 Solvents spatial distribution and concentrations in the sampled areas.

In Parcels 1, 2, and 6, fill material consisting of soils mixed with wood, brick, and concrete fragments had variable thicknesses, generally within the range of 5 to 20 ft thick. Solvents such as PCE, TCE, 1,1-DCE, 1,1,2-TCA, VC (vinyl chloride), and ketone were found in soils/fill across all sampled areas, at depths ranging from approximately 0.5 ft to 64.5 ft bgs. These solvents were not associated with the former MGP operations. The highest concentration of TCE (22 mg/kg; 34 ft bgs) was detected in a sample collected from a soil boring located at the Pratt Works site (Parcel 6), along N. 12th Street. Elevated TCE concentrations at that depth may suggest the presence of a chlorinated solvent source area that resulted in the downward migration of the DNAPL⁵ TCE. Figure 5.1 presents the distribution and concentration of solvent detections.

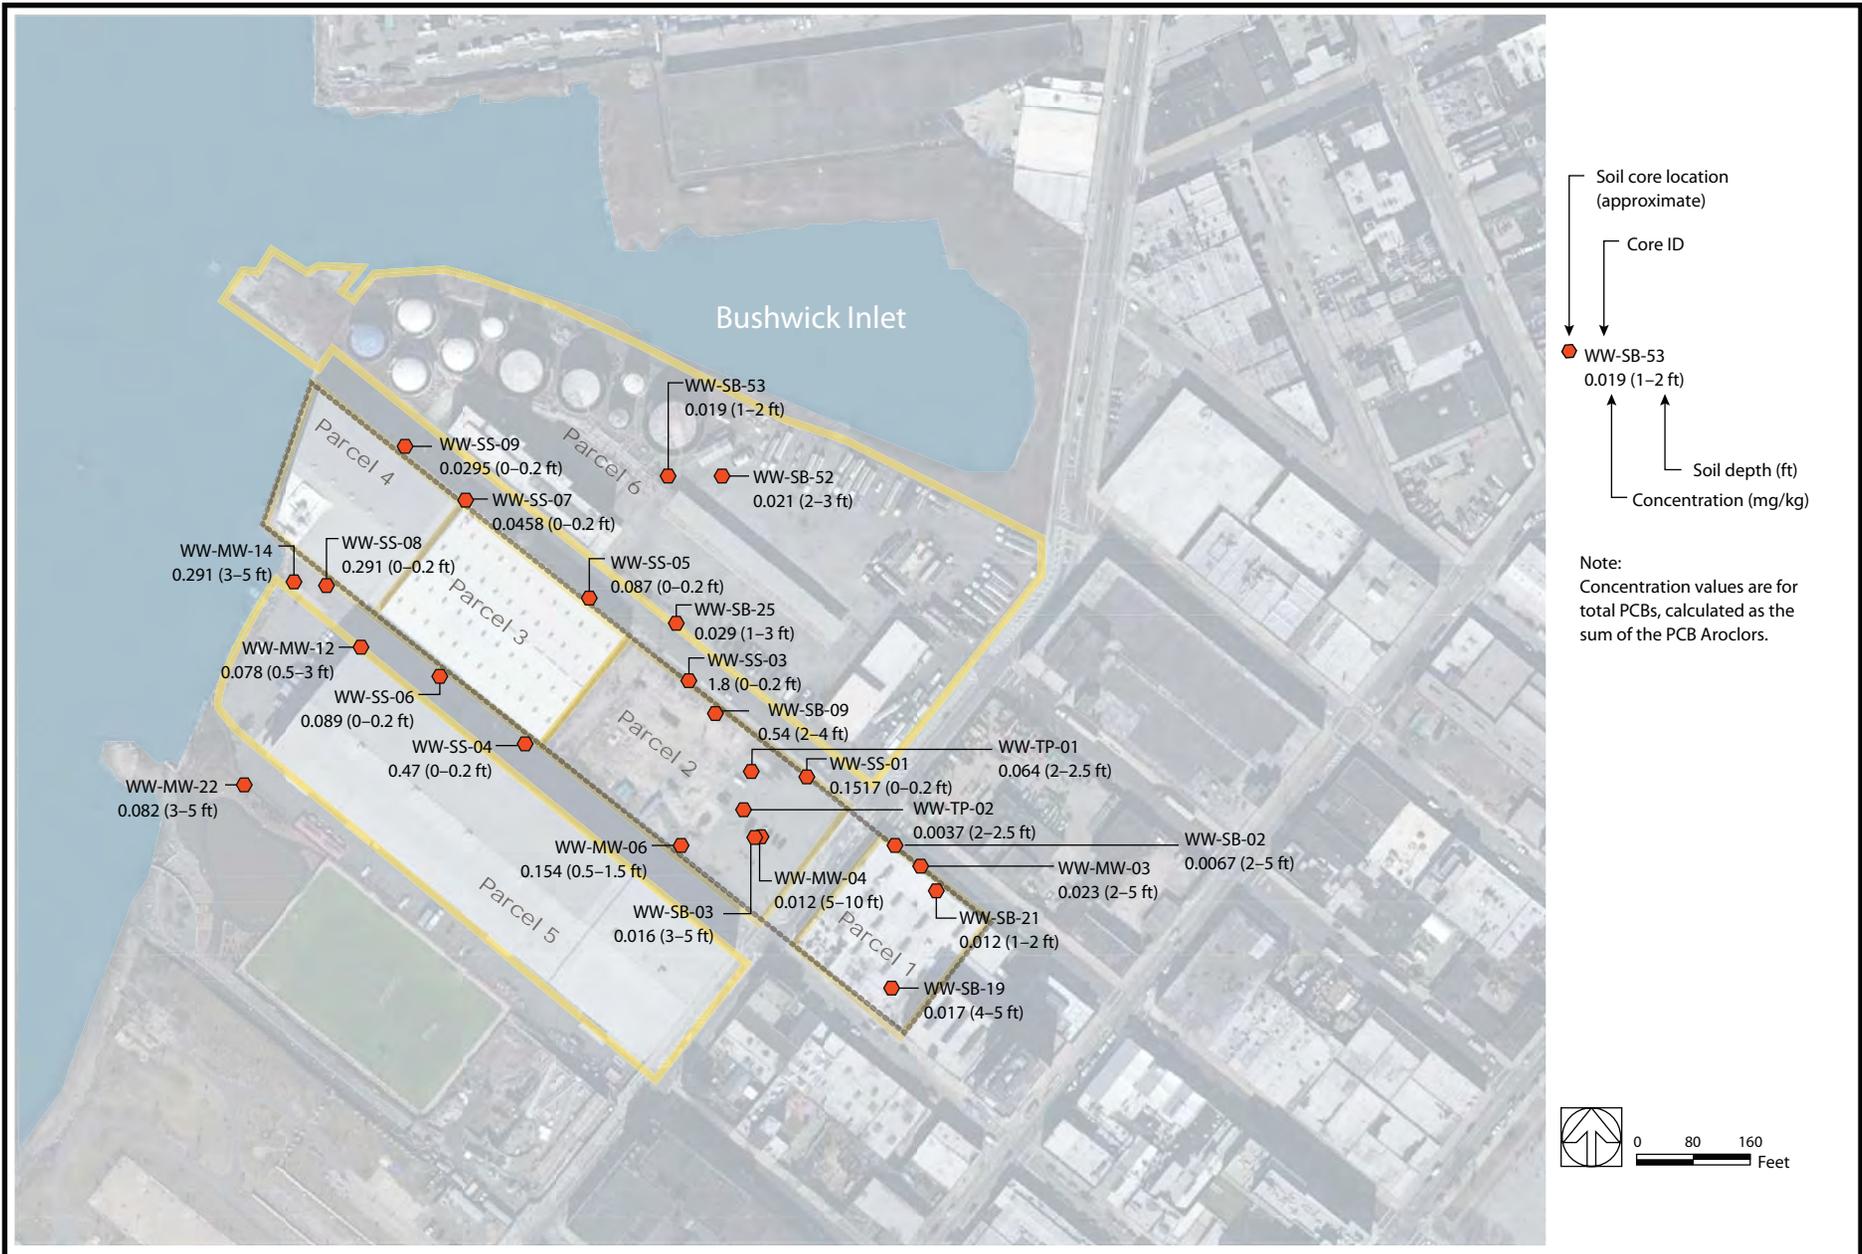
Figure 5.2.1 PCBs spatial distribution and concentrations in the sampled areas.

PCBs are non-MGP compounds that were detected in surface soil samples (0–0.2 ft), and shallow soil samples (down to 7.5 ft bgs) at locations throughout the different parcels (see Figure 5.2.1). The highest PCB concentration in surface soils (1.8 mg/kg) at the Parcel 2 boundary with N. 12th Street was higher than the unrestricted-use SCO of 0.1 mg/kg. Within Parcel 2, PCB levels up to 0.54 mg/kg (2–4 ft; SB-09) were found. PCBs were also detected in soil samples from Parcel 6 and from around Parcel 5. Sheet metal manufacturing, the corrugated containers and scrap metal operations, among other activities that occupied the former MGP parcels are potential PCB sources.

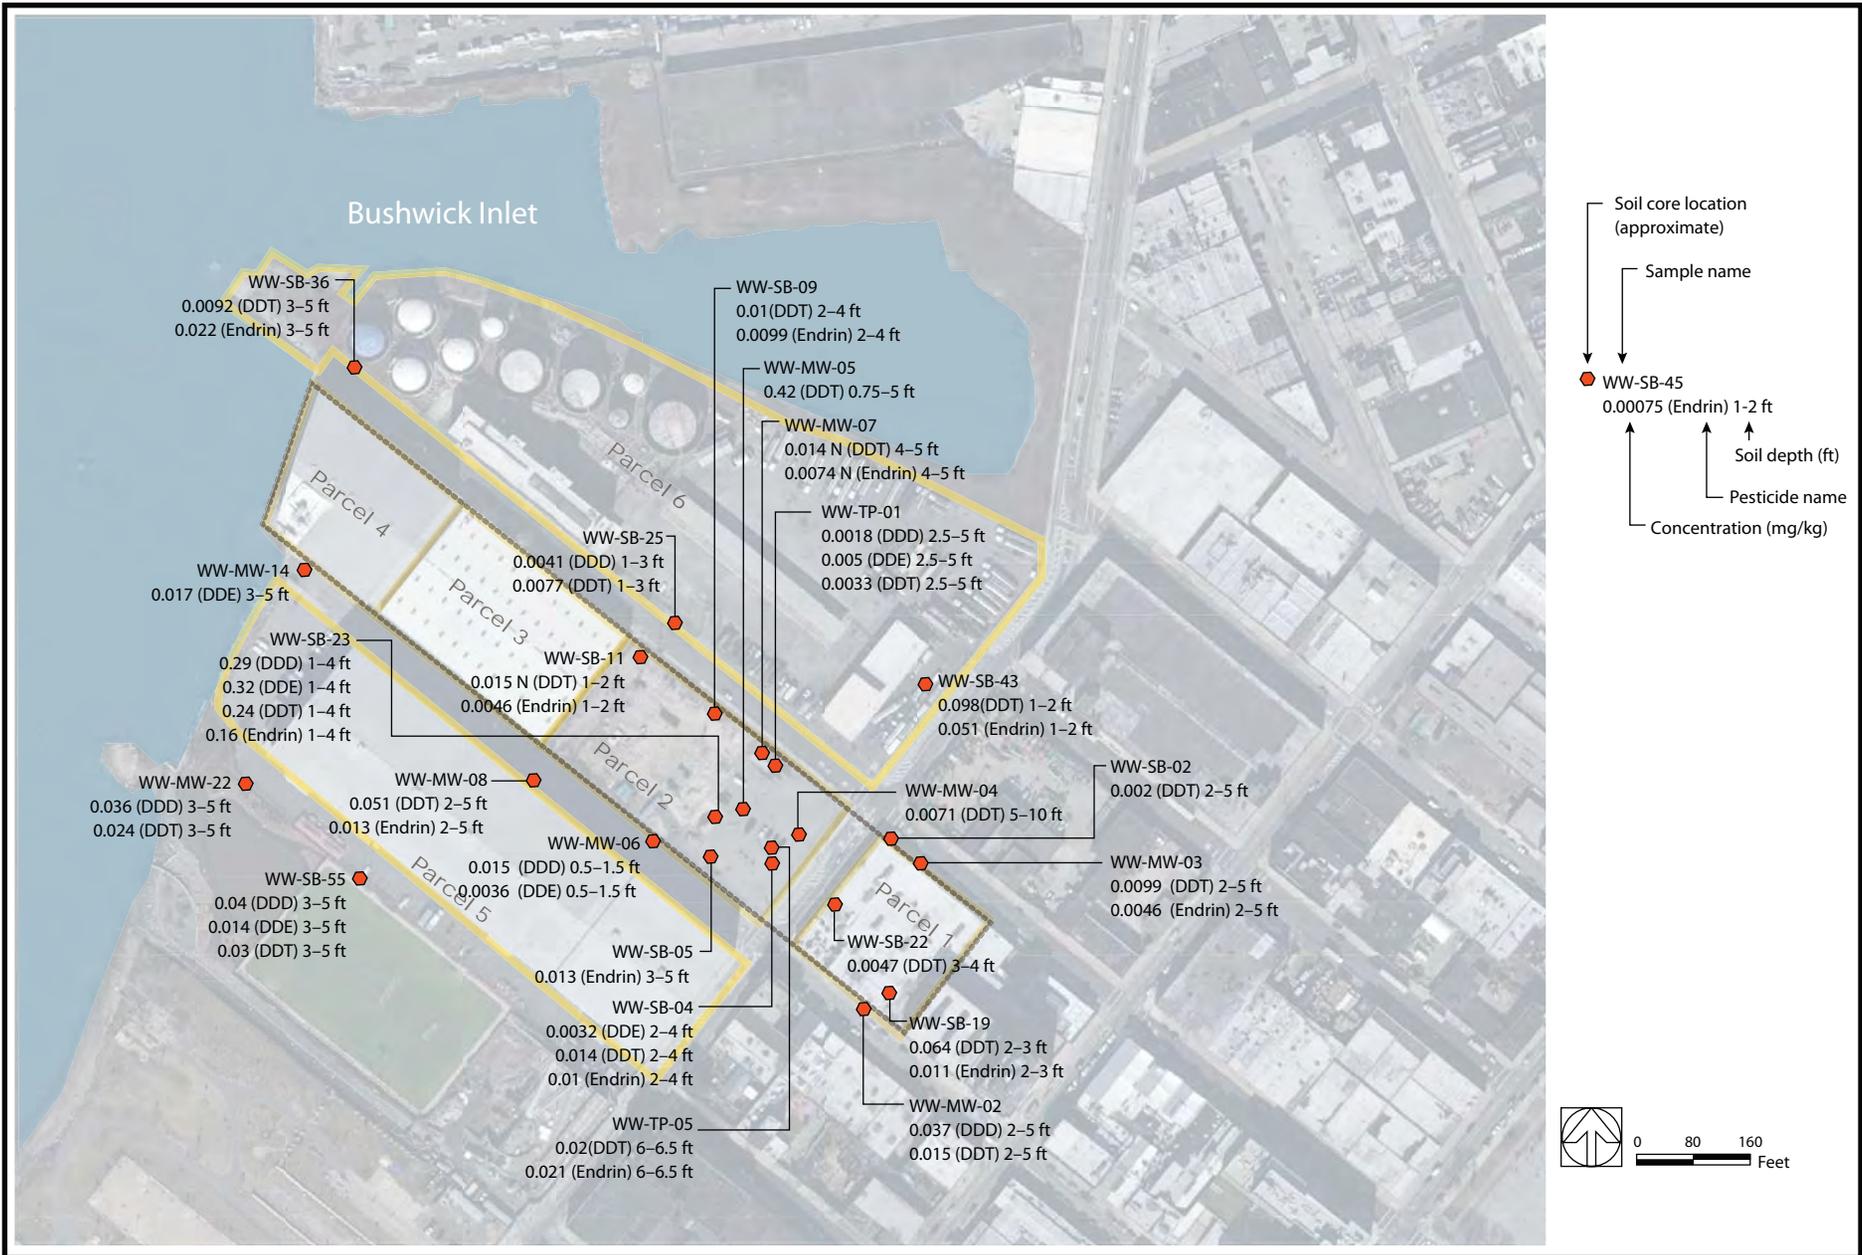
Figure 5.2.2 Spatial distribution and concentrations of selected pesticides in sampled areas.

Pesticides were detected at elevated concentrations compared to the unrestricted-use SCO at all sampled areas. In the surface soil samples (0–0.2 ft), DDT concentration was up to 0.15 mg/kg, higher than the unrestricted-use SCO of 0.0033 mg/kg. In Parcel 2, the highest DDT concentration of 0.42 mg/kg (two orders of magnitude higher than the unrestricted SCO) was detected in a sample collected from 0.75–5 ft (at location WW-MW-05). Other pesticides (e.g., DDD, DDE, and Endrin), with concentrations above their respective unrestricted-use SCOs, were also detected throughout the different parcels (see Figure 5.2.2).

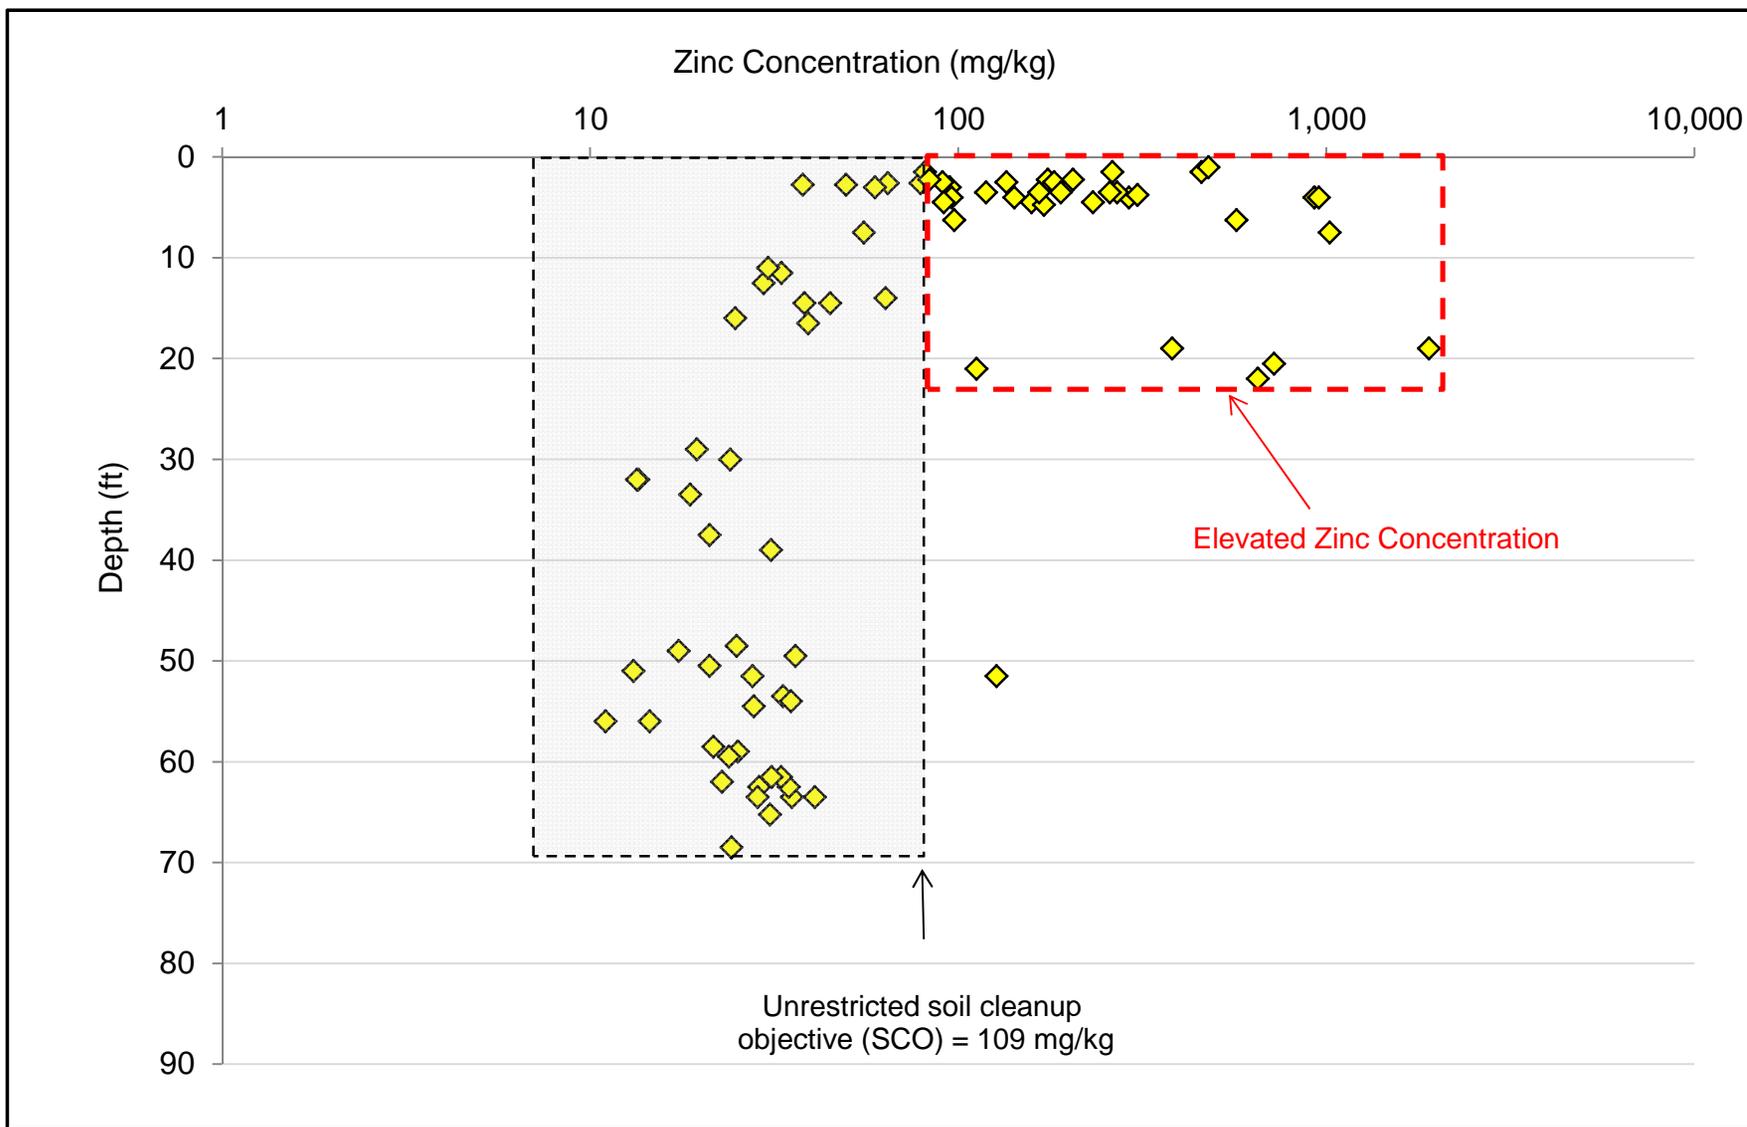
Figure 5.3.1 Zinc concentrations were elevated in the top 20 feet of soil/fill in Parcels 1 and 2.

In the top 20 ft of the former MGP site (Parcels 1 and 2), zinc concentrations were up to 2,000 mg/kg, while concentrations were generally less than 109 mg/kg (the unrestricted-use

SCO for zinc in soil) in soils deeper than 20 ft (see Figure 5.3.1). This pattern was also observed in Parcel 6 (Figure 5.3.2). Elevated copper concentrations were also found in the shallow soil/fill samples from Parcels 1, 2, and 6 compared to the deeper soils (Figures 5.3.3 and 5.3.4).
