**Former Williamsburg Works
MGP Site, Brooklyn,
New York**

**Analysis of Available Data to
Track Sources of
Contamination**

January 30, 2015

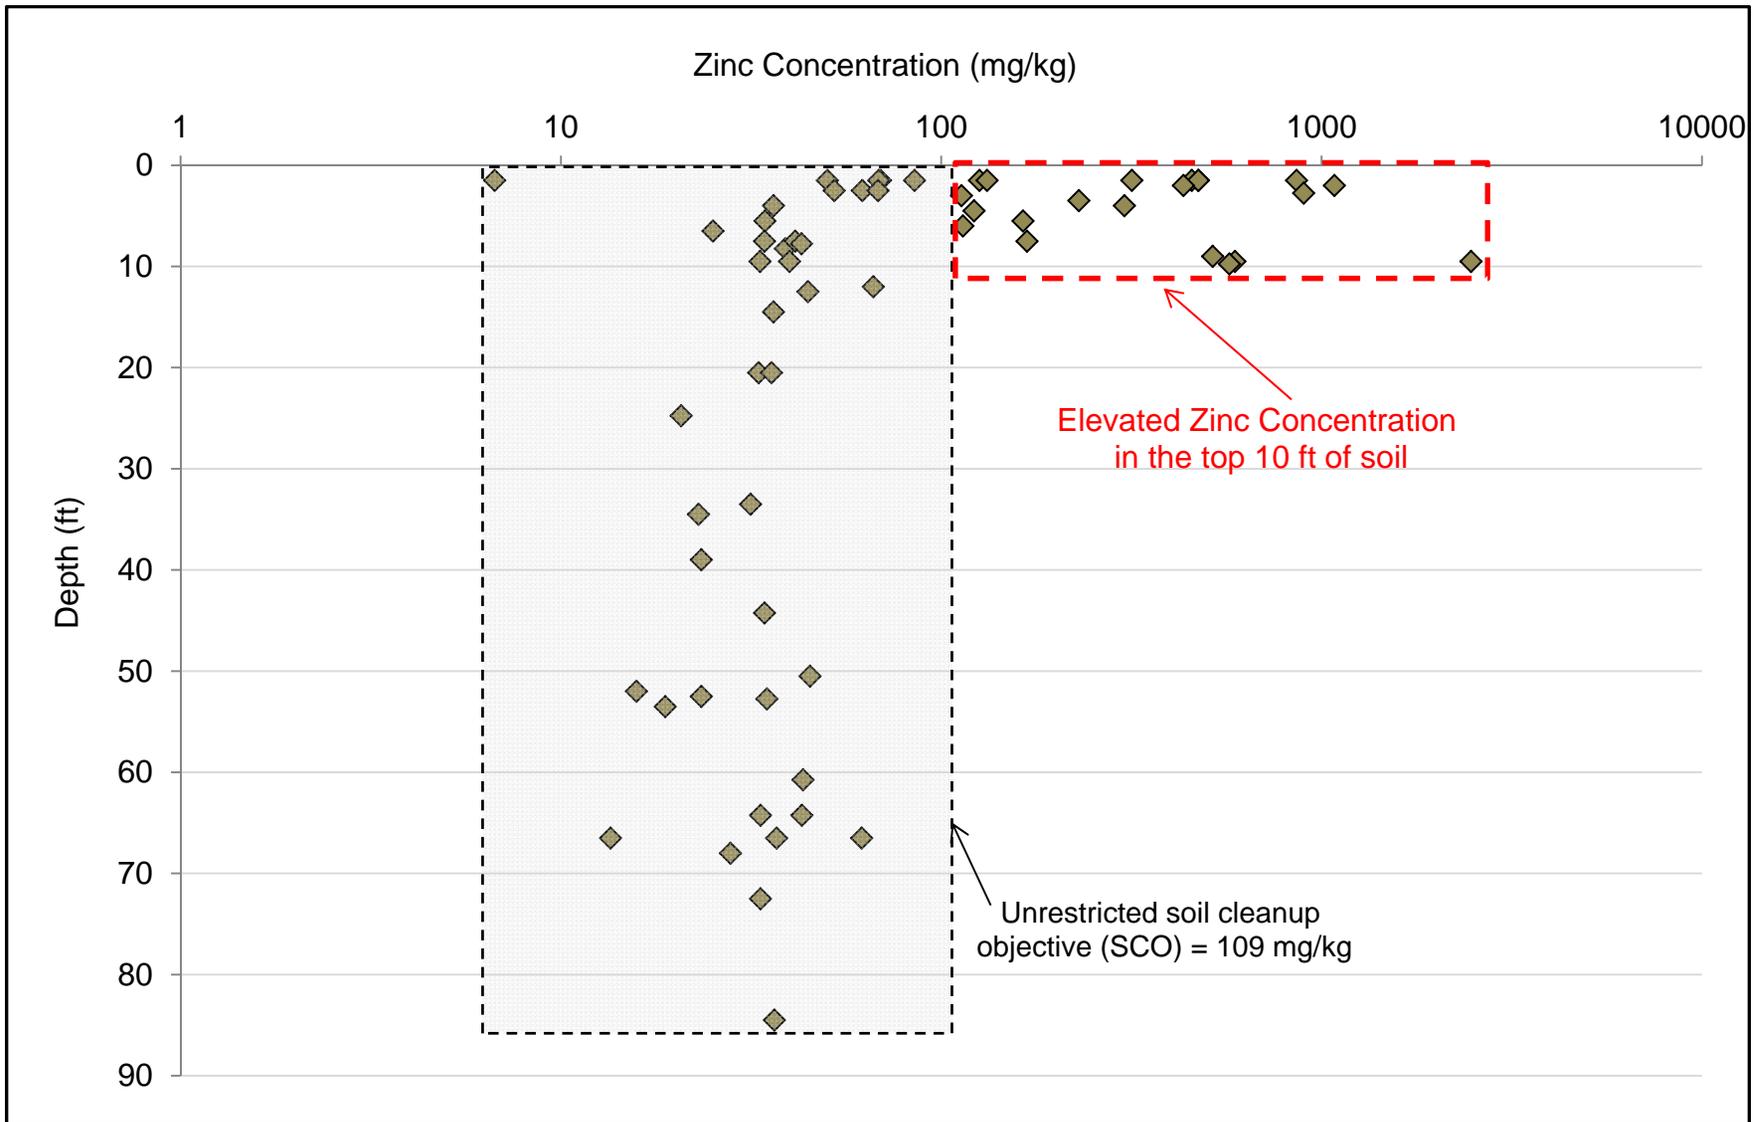
Figure 5.3.2 Zinc concentrations were elevated in the top 10 feet of soil/fill in Parcel 6.

SCO for zinc in soil) in soils deeper than 20 ft (see Figure 5.3.1). This pattern was also observed in Parcel 6 (Figure 5.3.2). Elevated copper concentrations were also found in the shallow soil/fill samples from Parcels 1, 2, and 6 compared to the deeper soils (Figures 5.3.3 and 5.3.4).

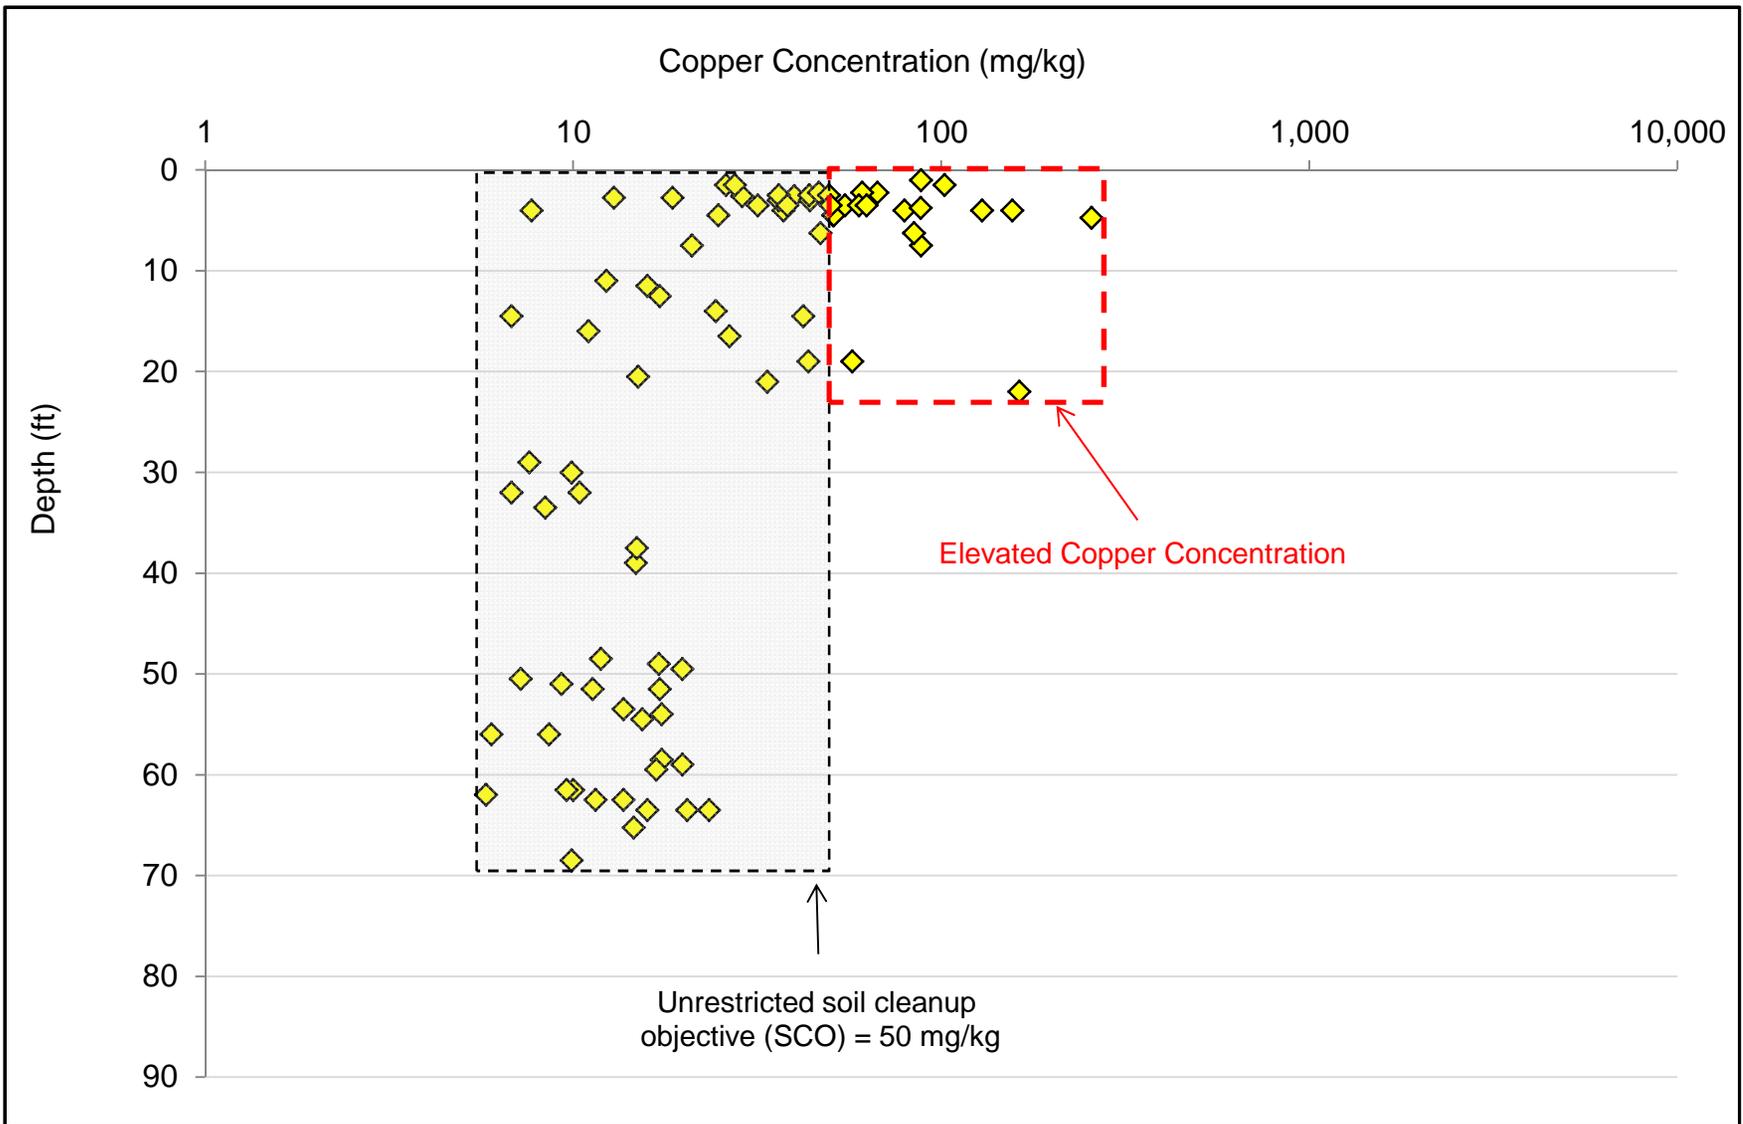
Figure 5.3.3 Copper concentrations were elevated in the top 20 feet of soil/fill in Parcels 1 and 2.

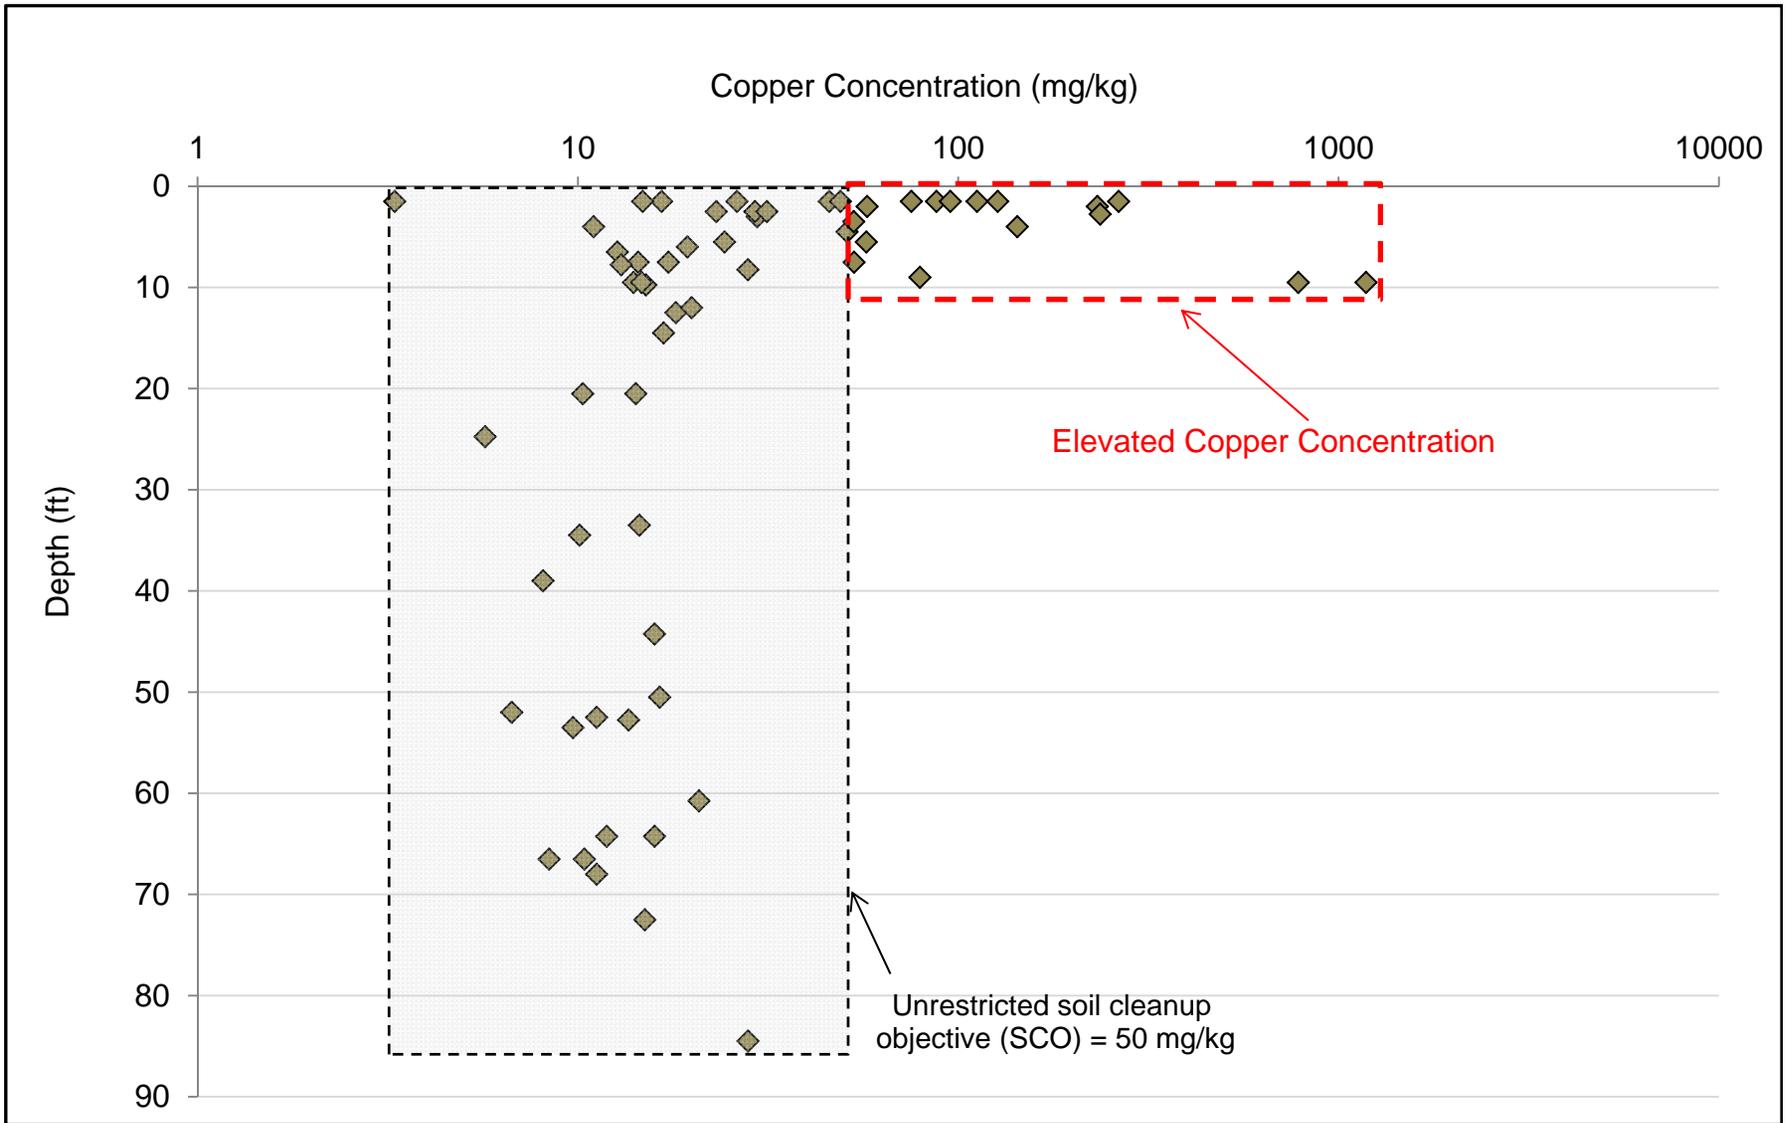
Figure 5.3.4 Copper concentrations were elevated in the top 10 feet of soil/fill in Parcel 6.

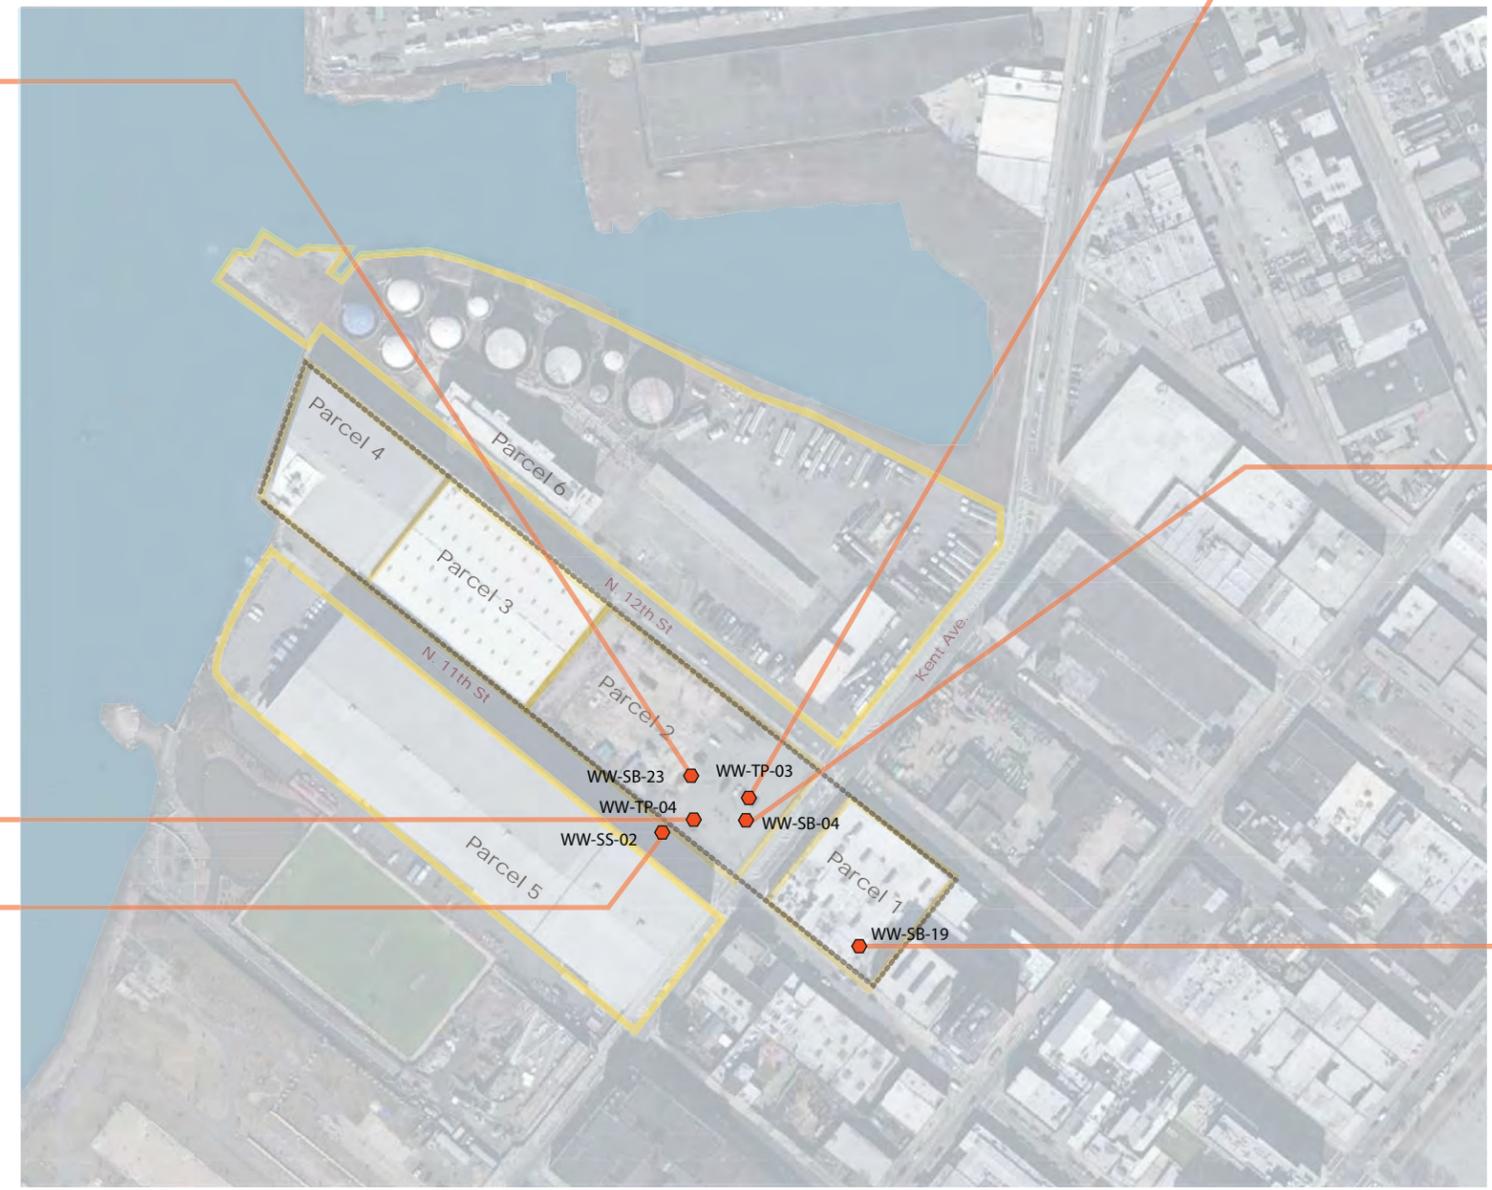
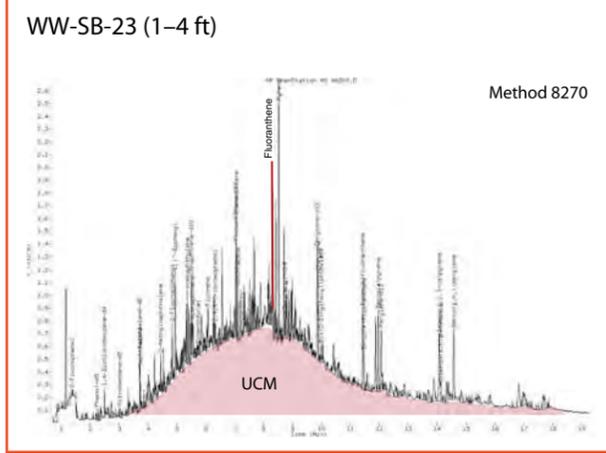
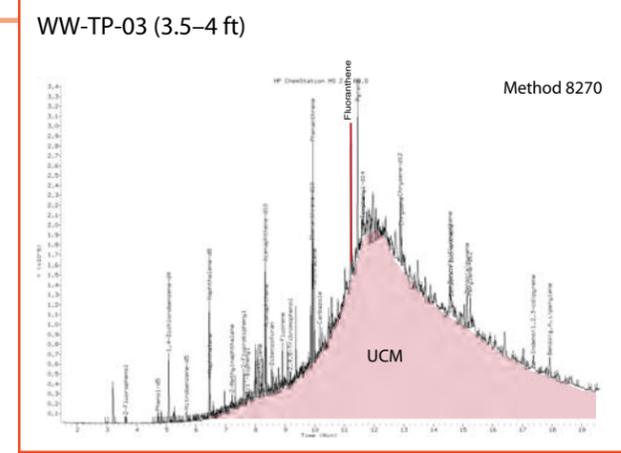
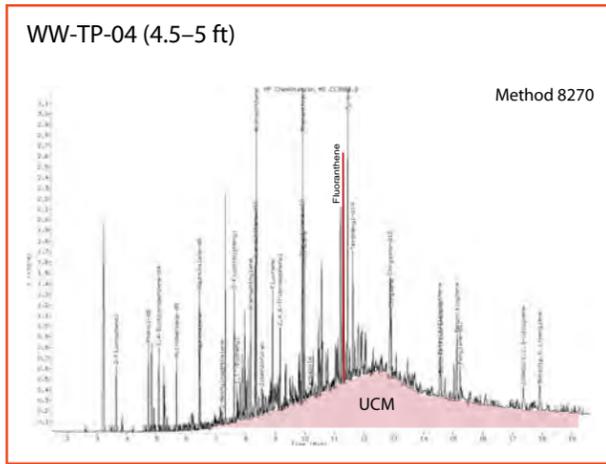
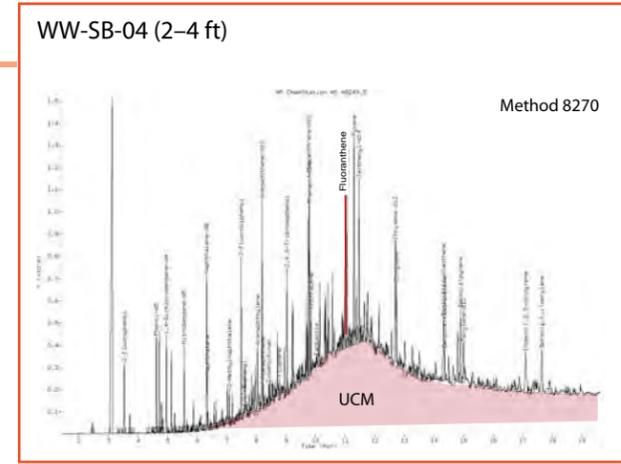
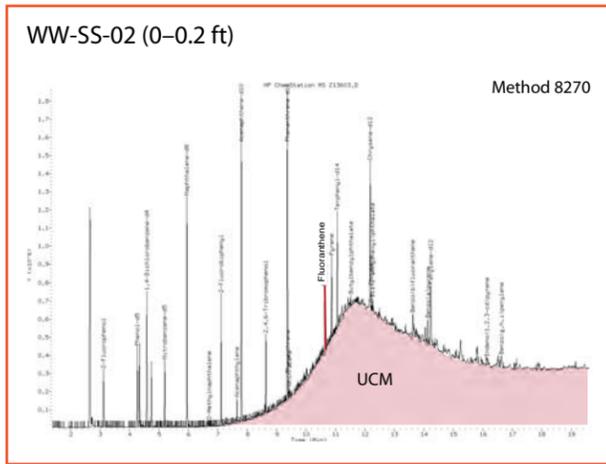
Figure 5.4.1
Gas chromatograms from the former MGP parcels indicate the presence of various petroleum products in the shallow soil/fill.

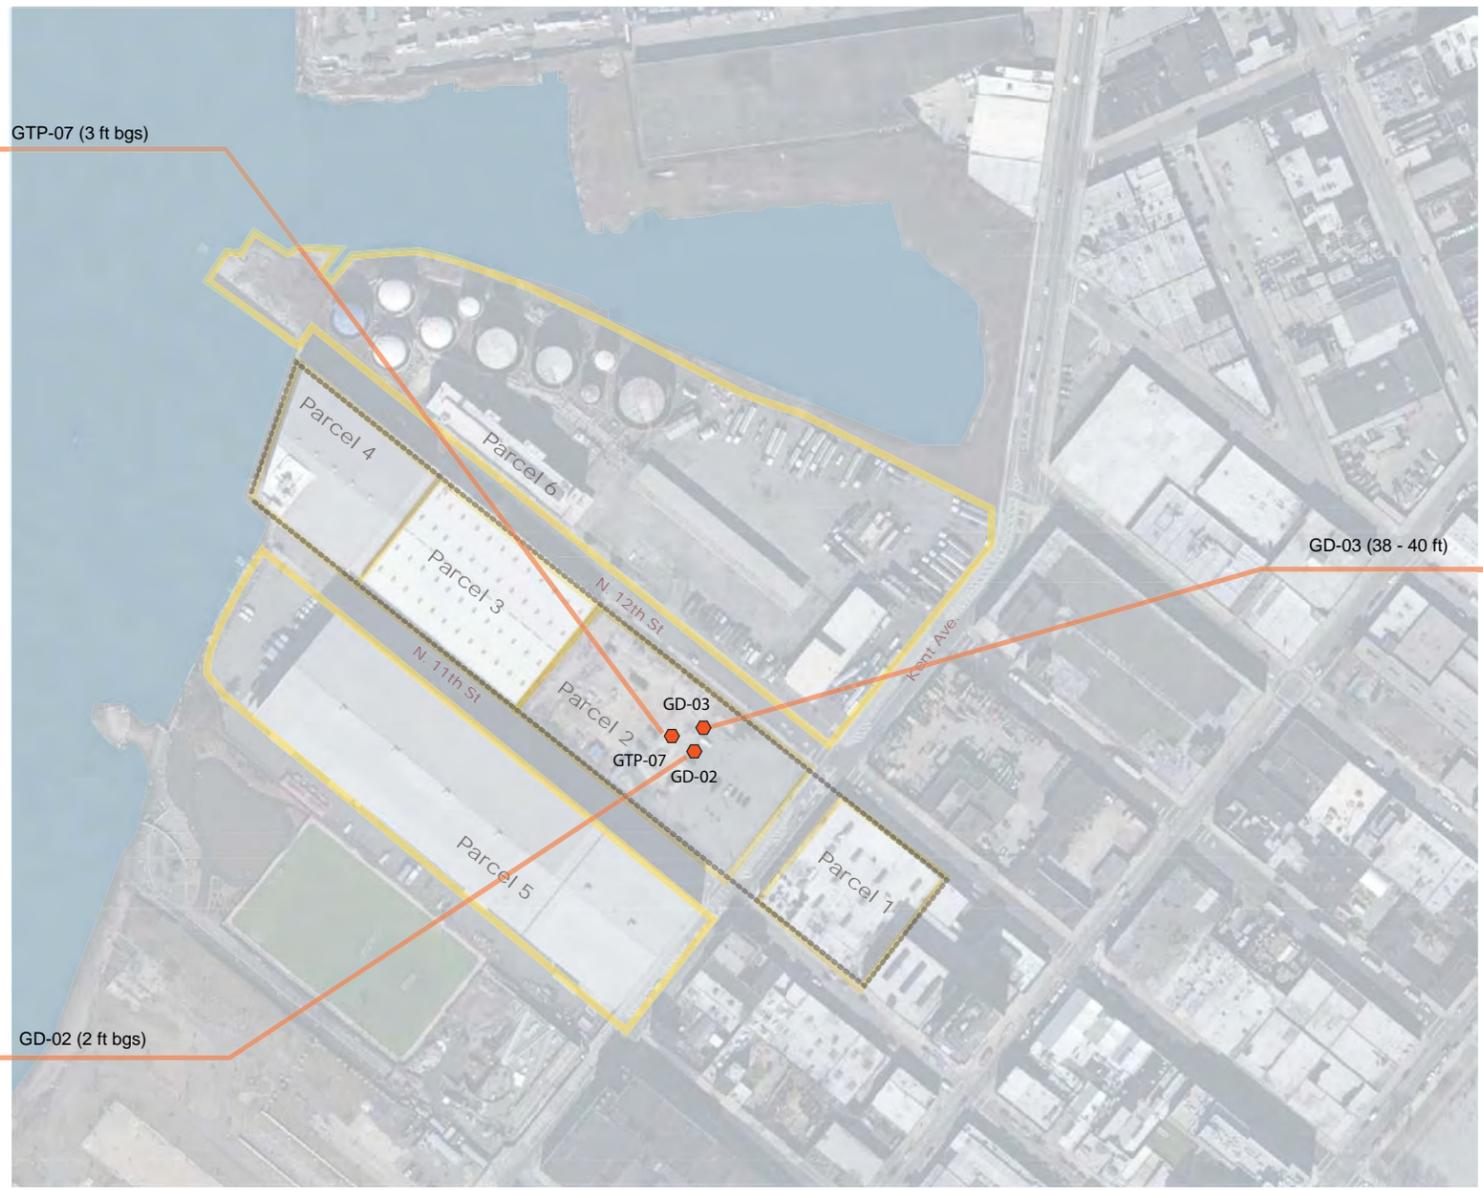
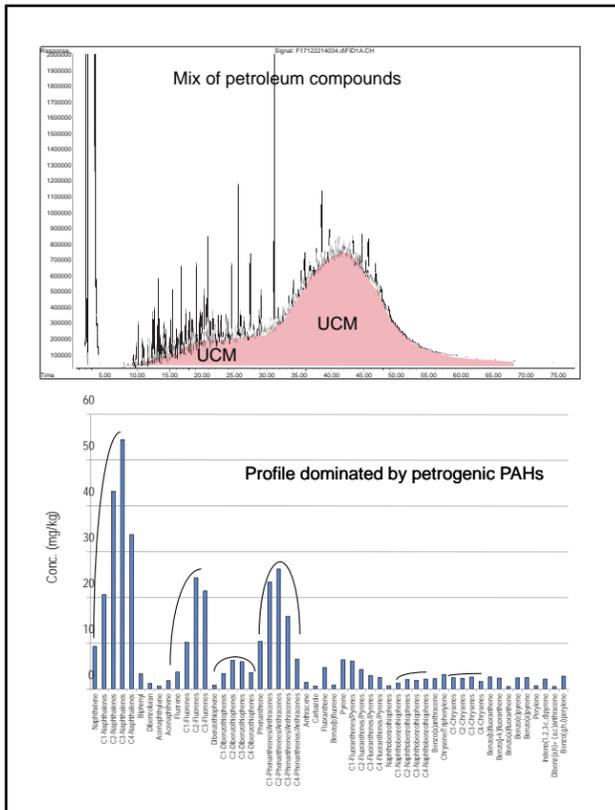
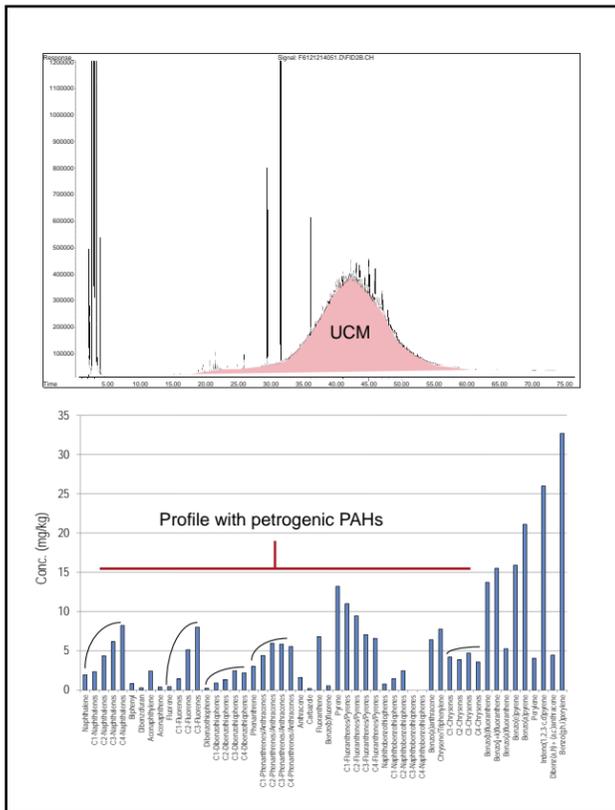
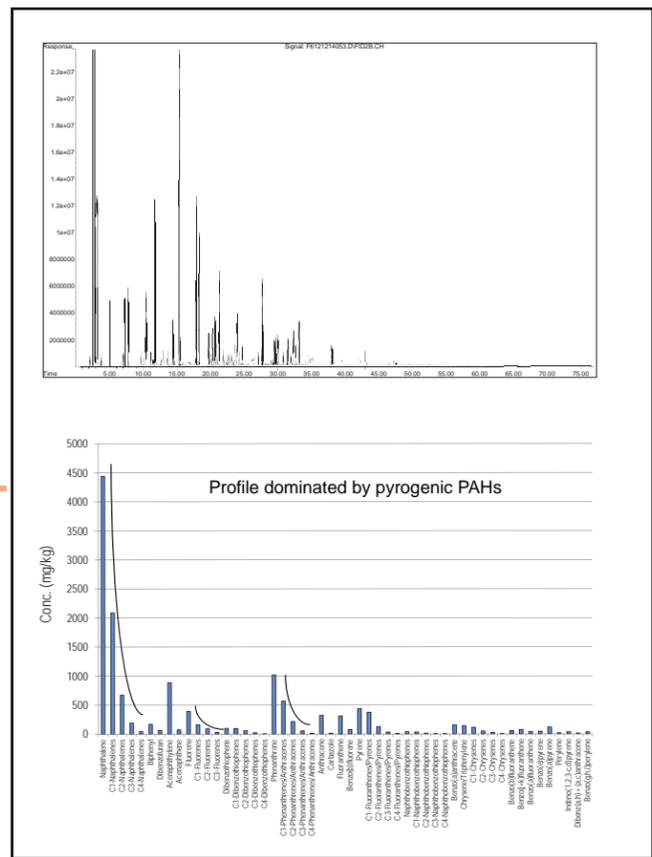
Figure 5.4.1.1 Fingerprinting analysis showed the presence of a mix of petroleum products in Parcel 2 shallow soil, inconsistent with impacts from the former MGP. The deep soil sample from Parcel 2 was impacted by tar.

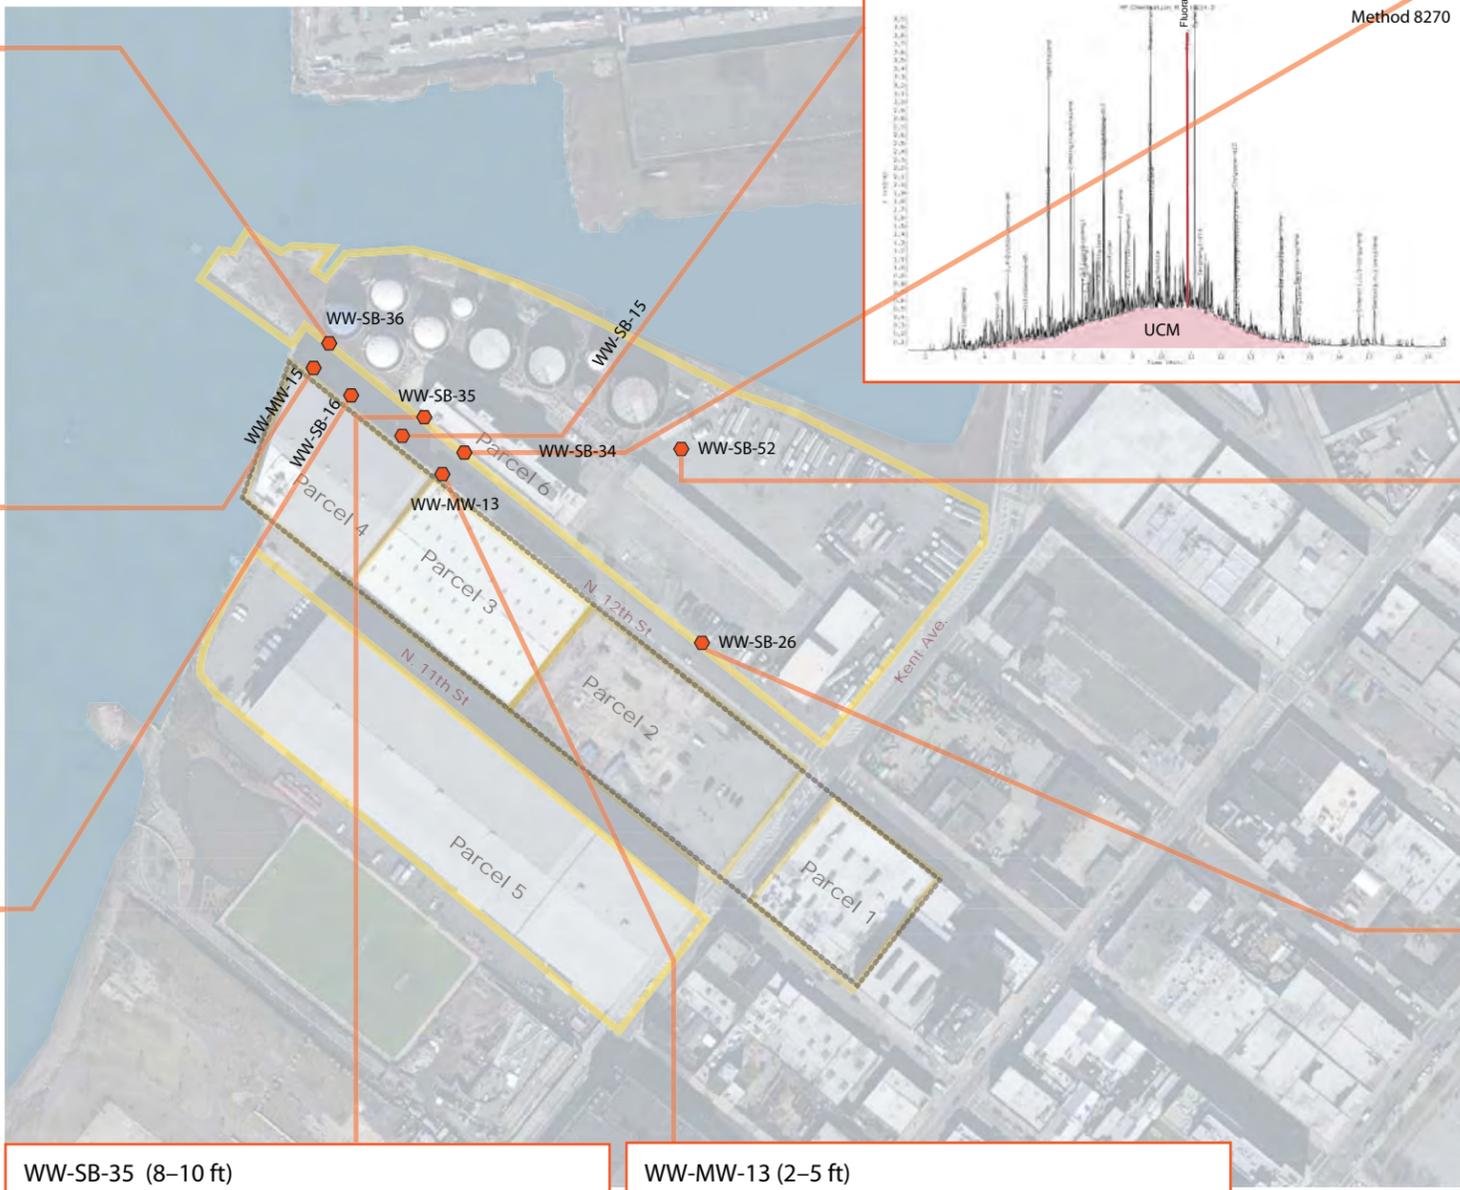
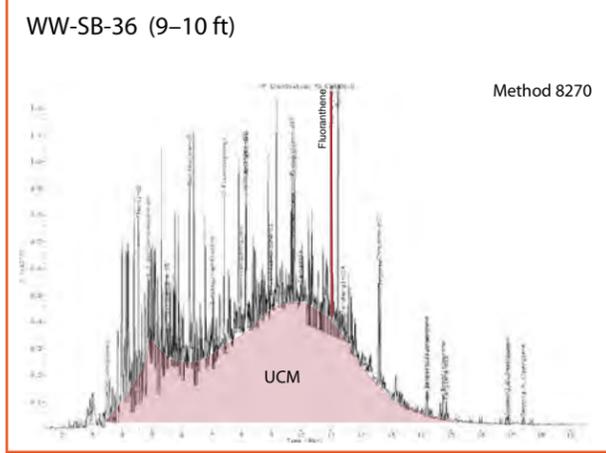
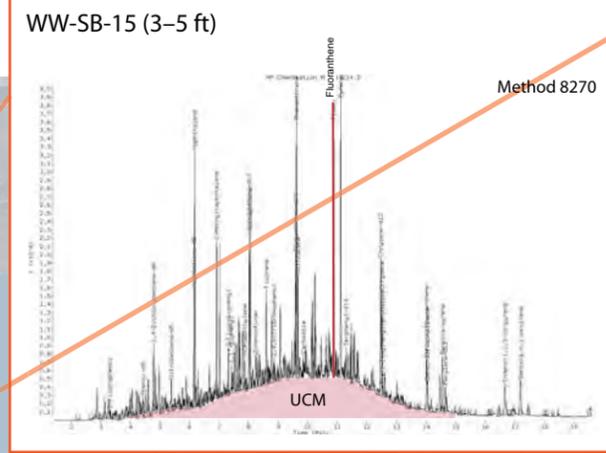
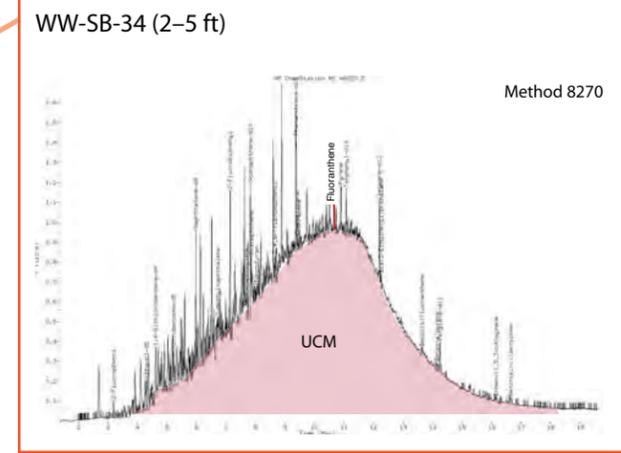
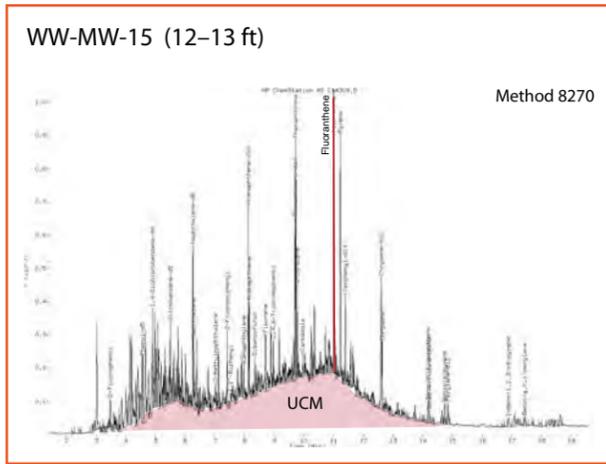
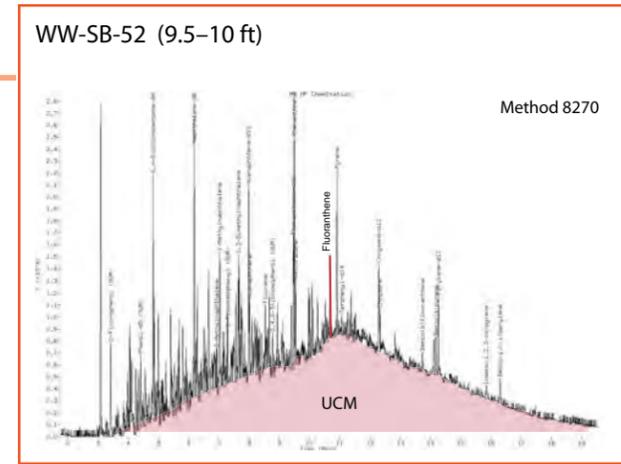
The different UCM shapes indicate the presence of various petroleum products.

Figure 5.4.2 Gas chromatograms from Parcel 6 and N. 12th Street indicate the presence of various petroleum products in the shallow soil/fill.

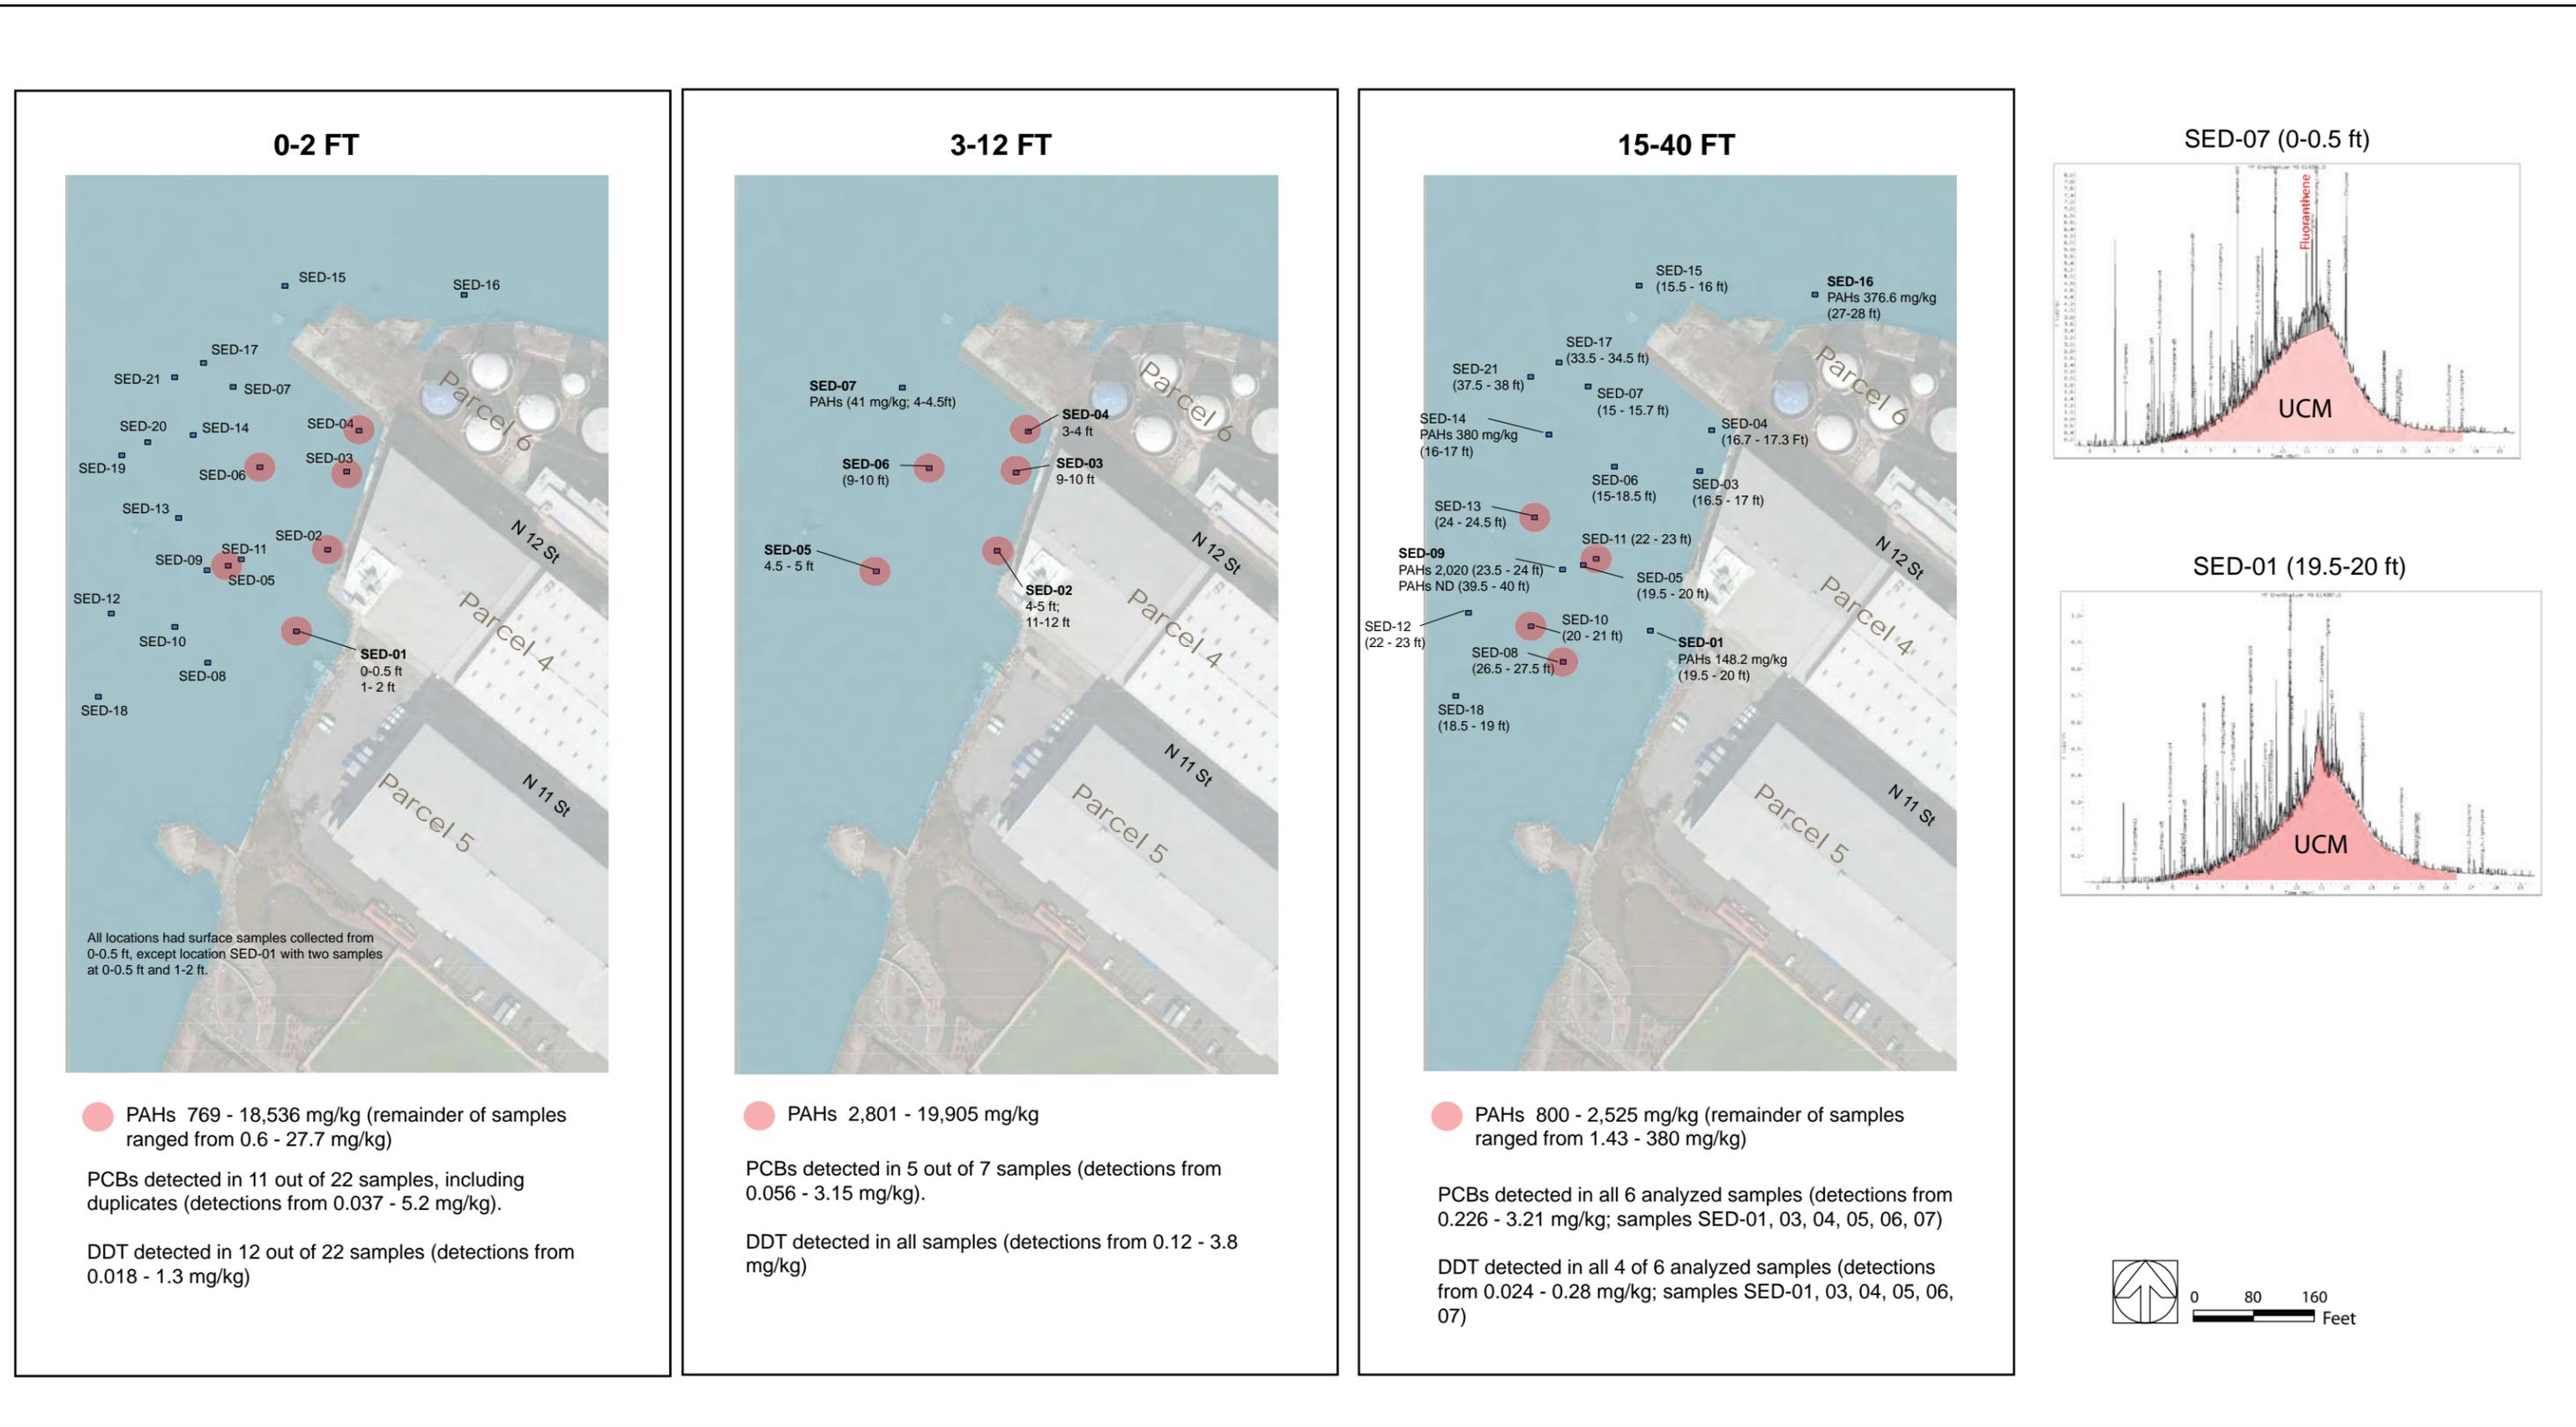
Figure 6.2 East River sediment sample locations and results.

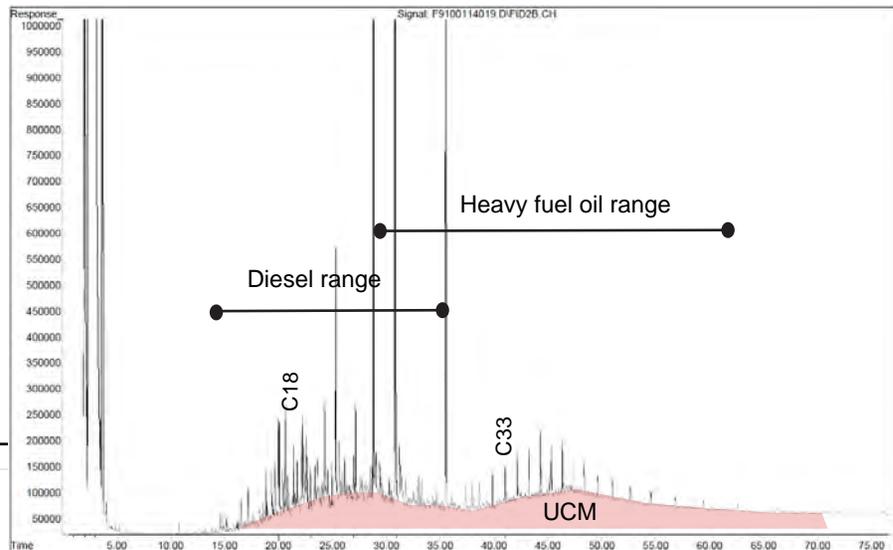
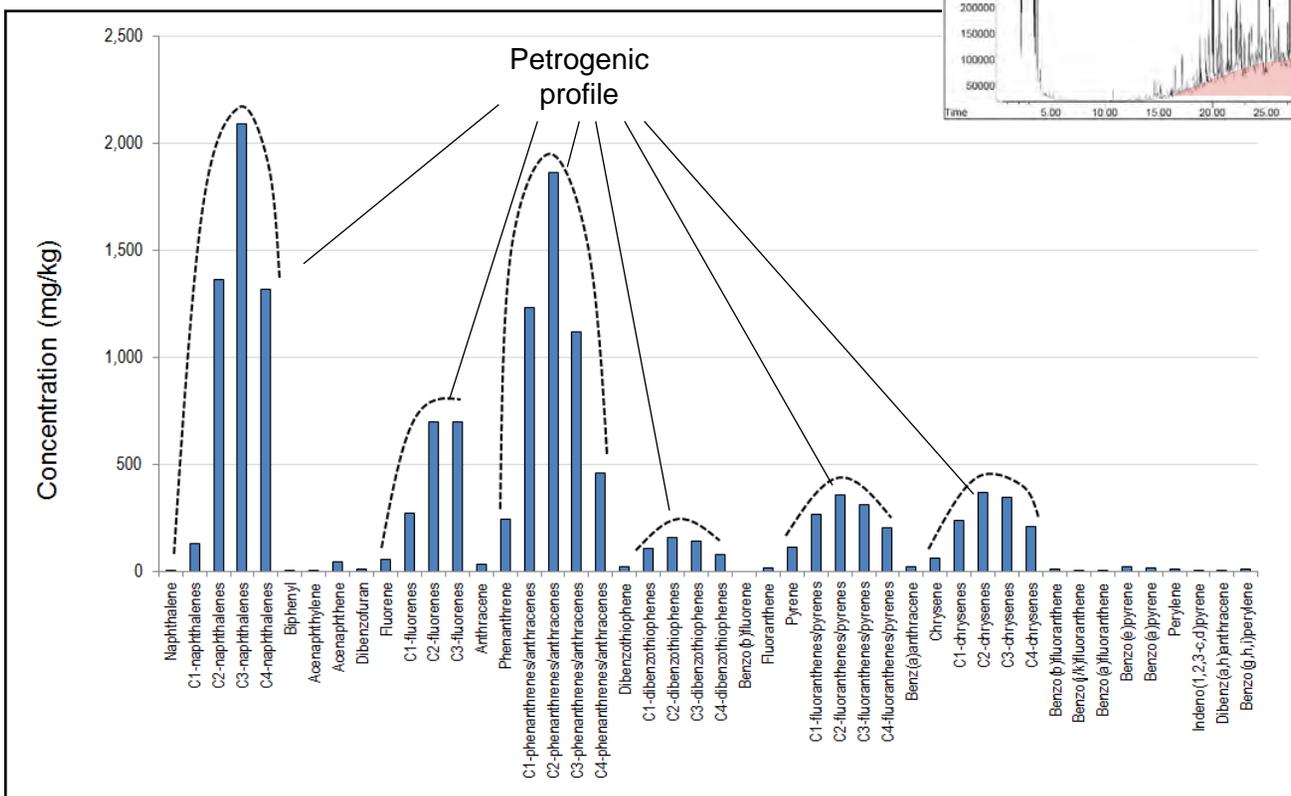
Verizon manhole NAPL (collected September 12, 2014)

Figure 7.2 PAHs in the Verizon manhole NAPL is from petrogenic origins. The gas chromatogram indicates the presence of a mixture of petroleum products, inconsistent with impacts from the former MGP.

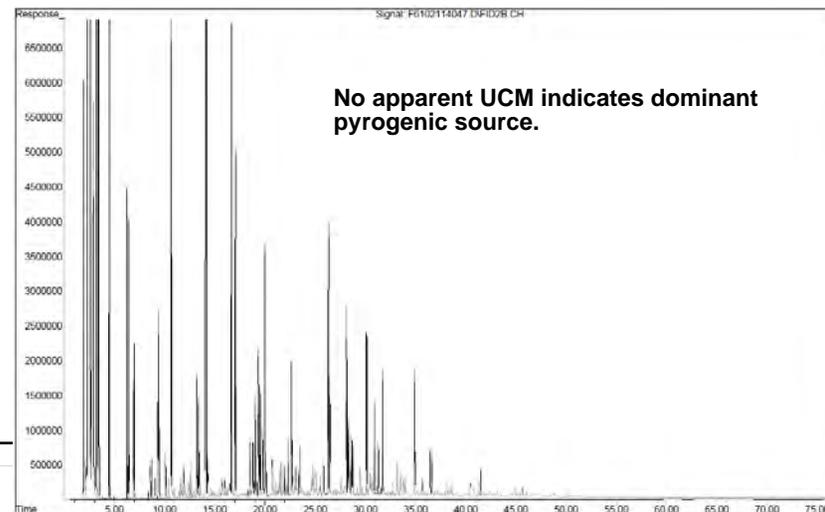
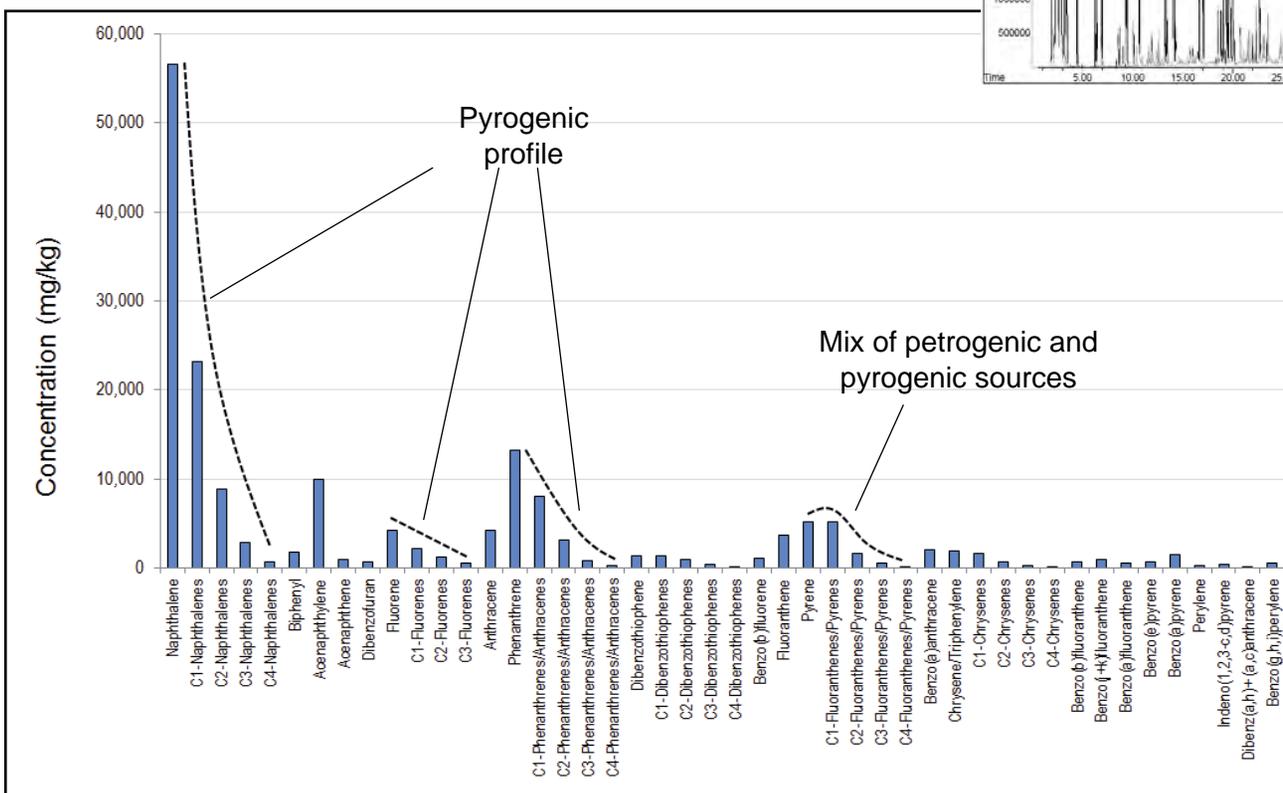
NRW-07 (collected November 19, 2014)

Figure 7.3 PAH profile for the NRW-07 NAPL sample indicates dominant pyrogenic PAHs, with a trace petrogenic source.
