**Former Williamsburg Works
MGP Site, Brooklyn,
New York**

**Analysis of Available Data to
Track Sources of
Contamination**

January 30, 2015

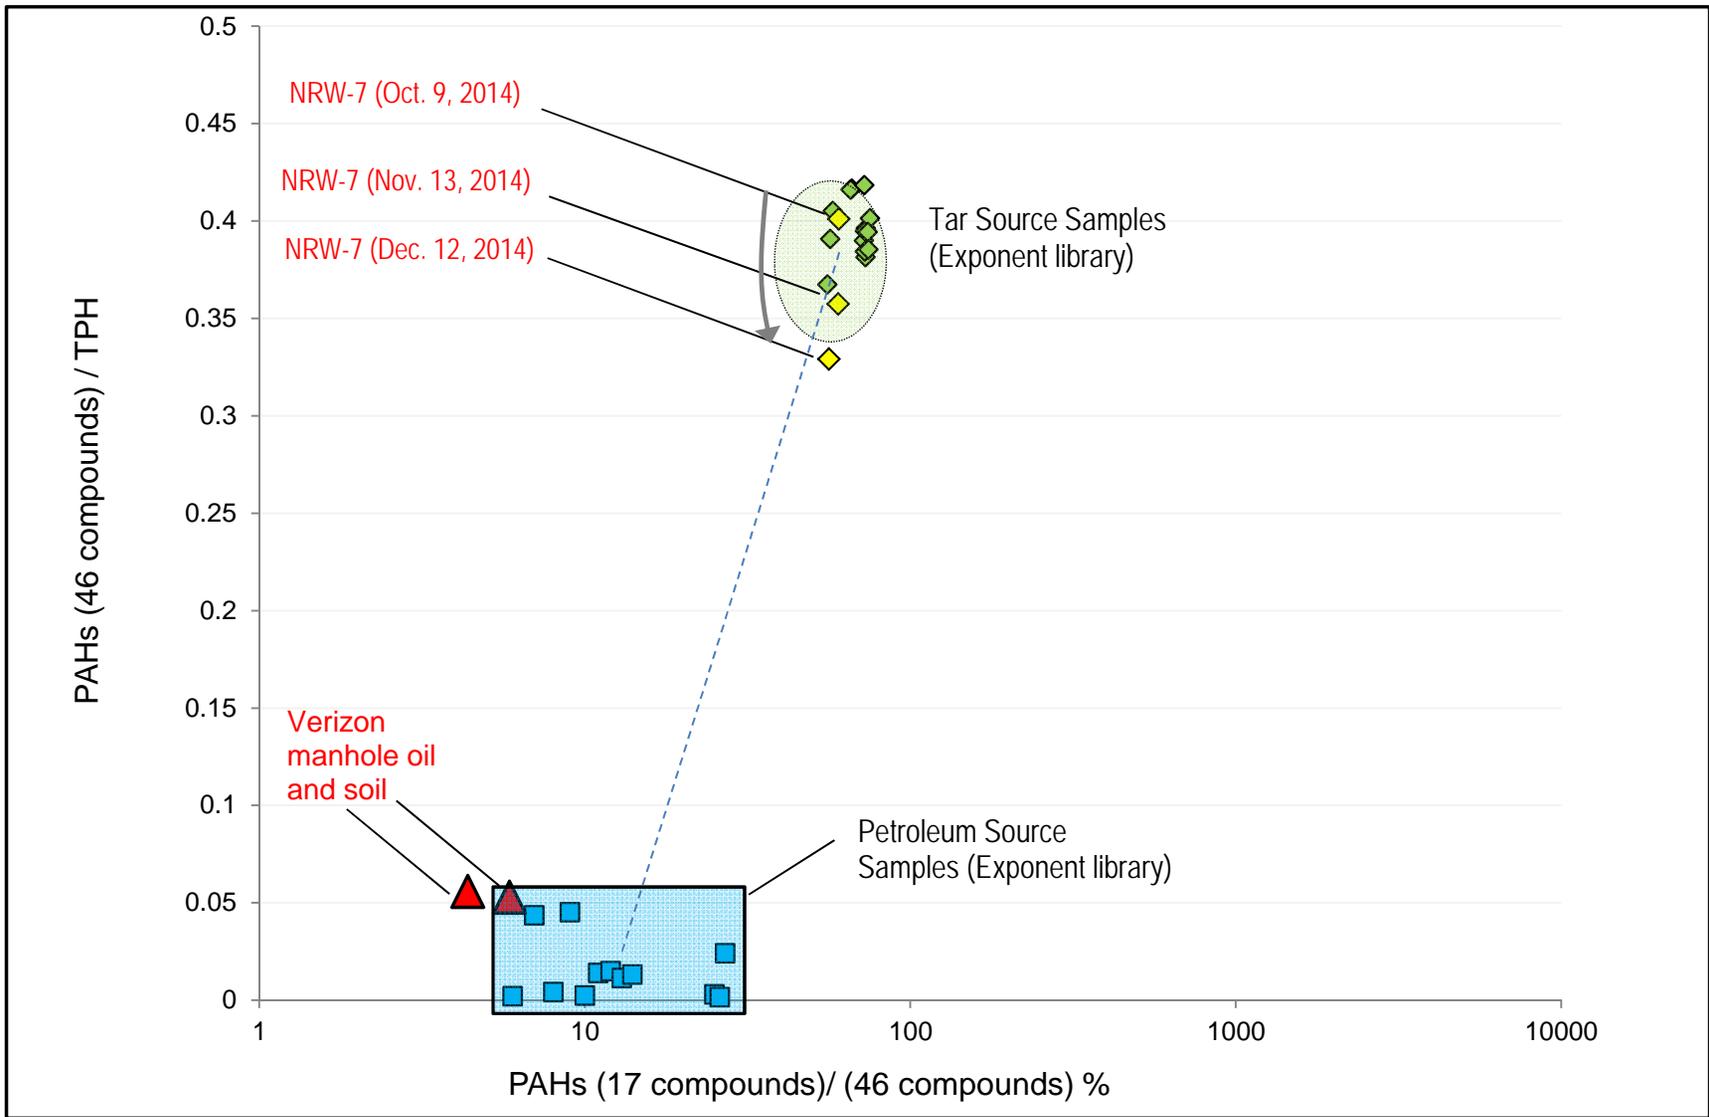
Figure 7.4. NRW-7 NAPL samples results with time.

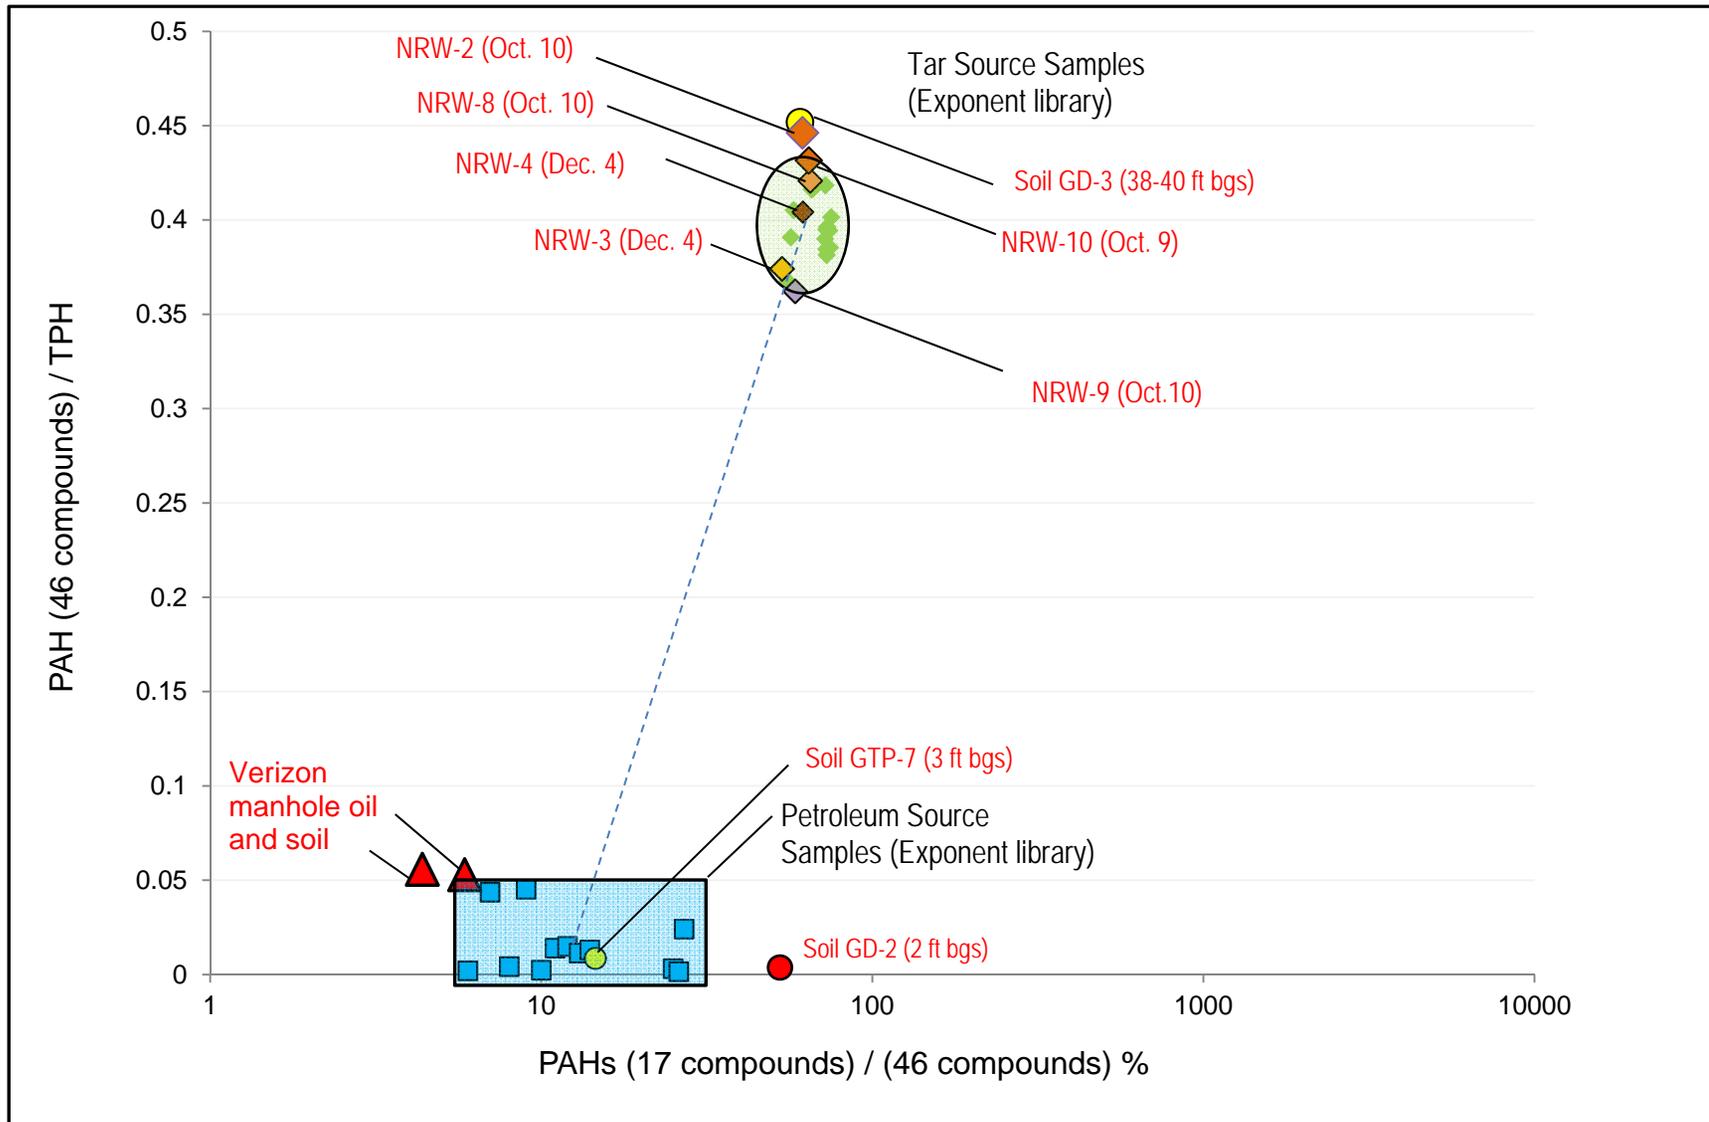
Figure 7.5. NAPL from the recovery wells contained PAHs from a pyrogenic dominant source. Verizon manhole NAPL and solid sample, and shallow soils from Parcel 2 were dominated by PAHs from a petrogenic source.
